BEECHER ROAD ELEMENTARY SCHOOL

EXISTING FACILITY CONDITION ASSESSMENT | 40 BEECHER ROAD, WOODBRIDGE, CT

March 4, 2026

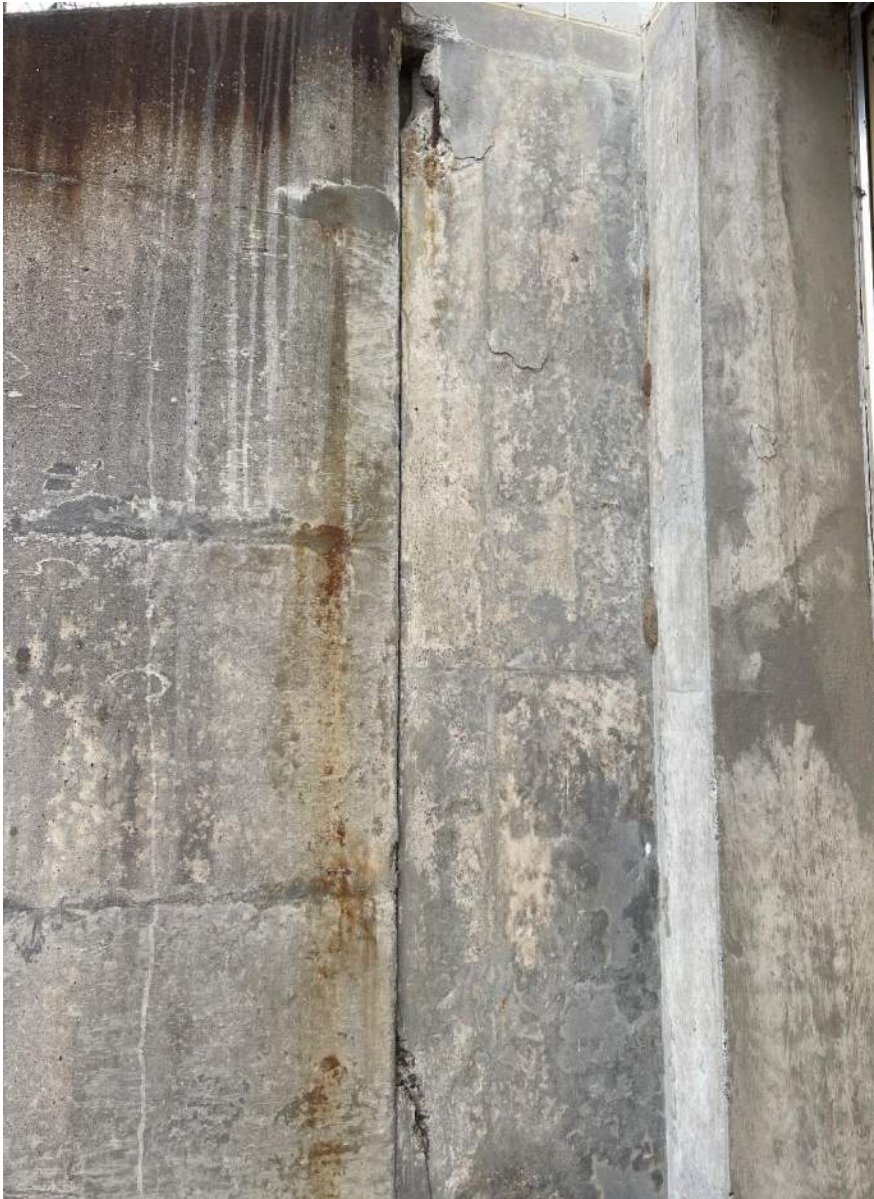
Exhibit #9: Severe cracking and delamination

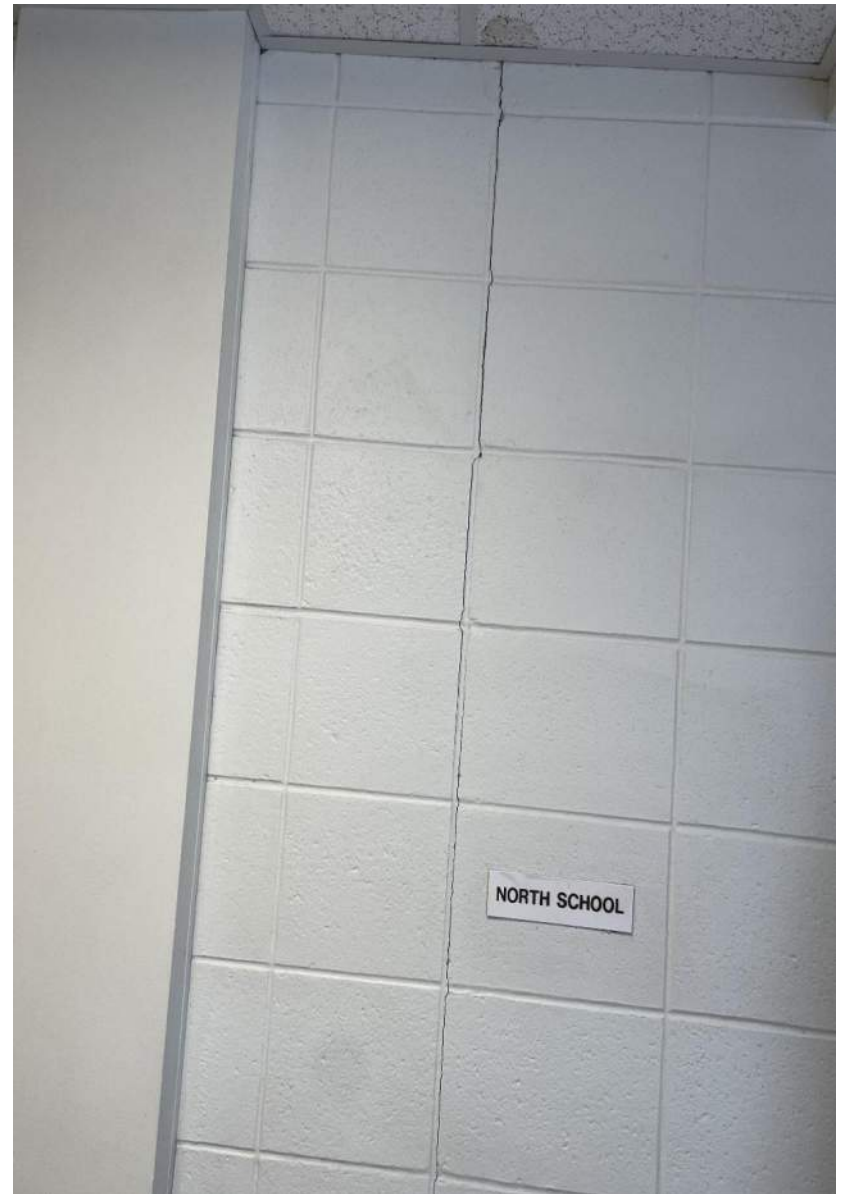
Exhibit #14: Slab on deck cracking at mechanical room

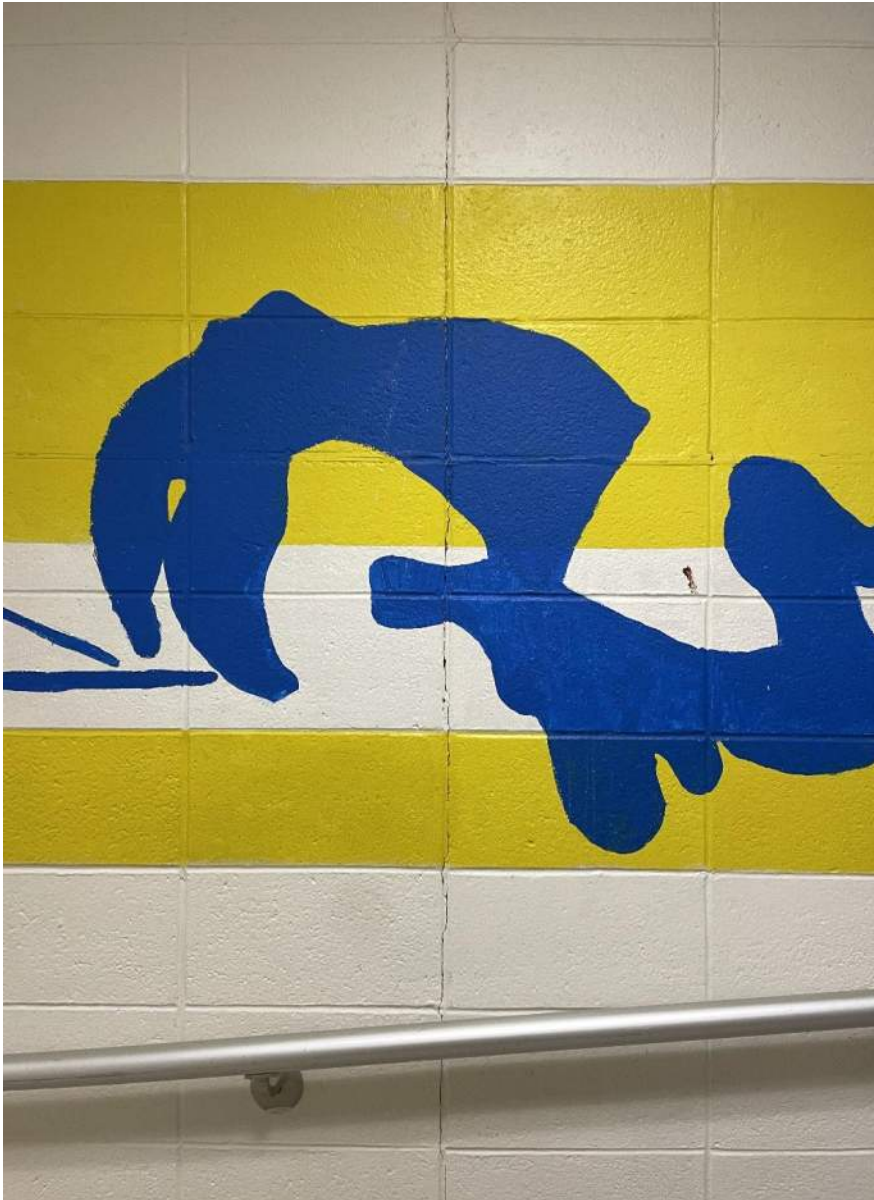
Exhibit #15: Cracking at CMU stacked bond (typical)

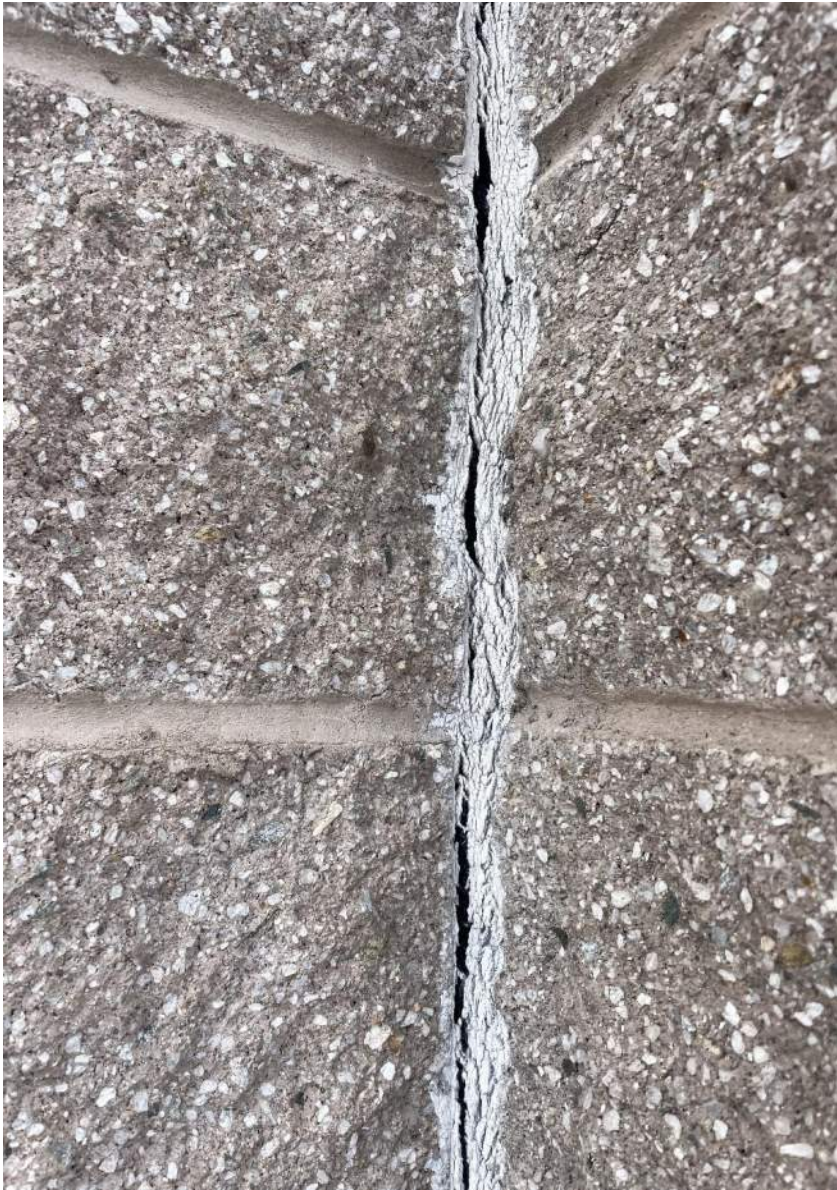
Exhibit #26: Joint sealant failure (typical)
