BEECHER ROAD ELEMENTARY SCHOOL

EXISTING FACILITY CONDITION ASSESSMENT | 40 BEECHER ROAD, WOODBRIDGE, CT

March 4, 2026

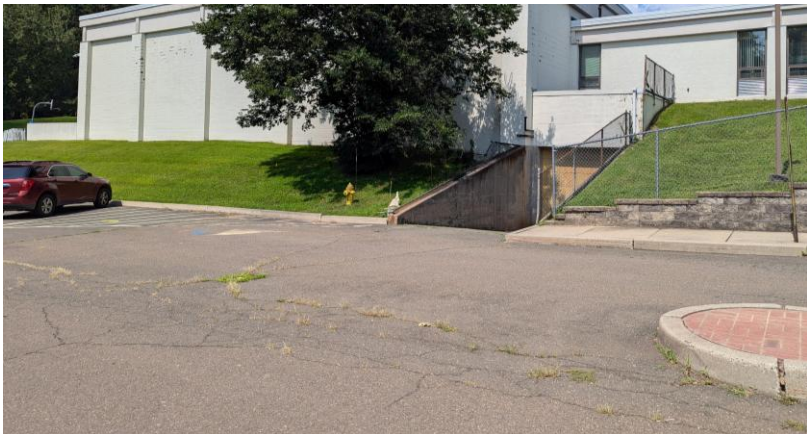
The southern lot, with an elevation ranging from 290 to 310 feet, requires some hills and steps to navigate before reaching the Southern Entrance. However, there are several accessible spaces located adjacent the drop off area, as well as in the upper level of the lot. The paving surfaces in these lots are worn and showing signs of alligator cracking and large gaps with organic material growth.

Visible alligator cracking and organic growth. South parking lot.

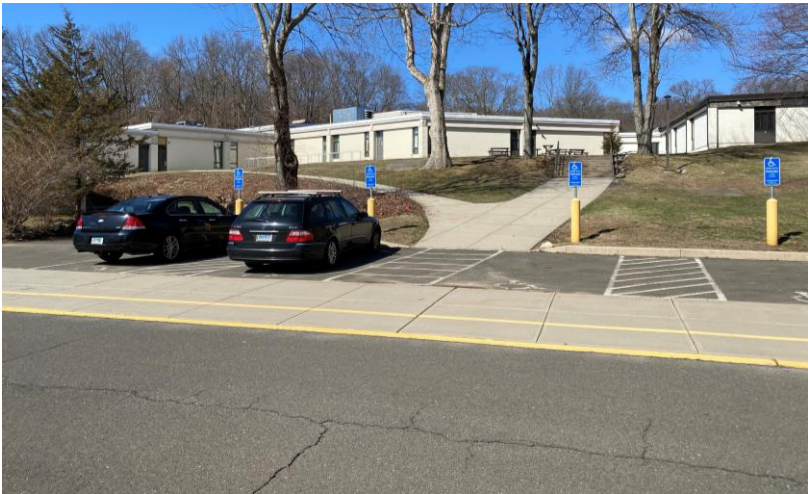
Accessible parking at the south parking lot. Visible alligator cracking.

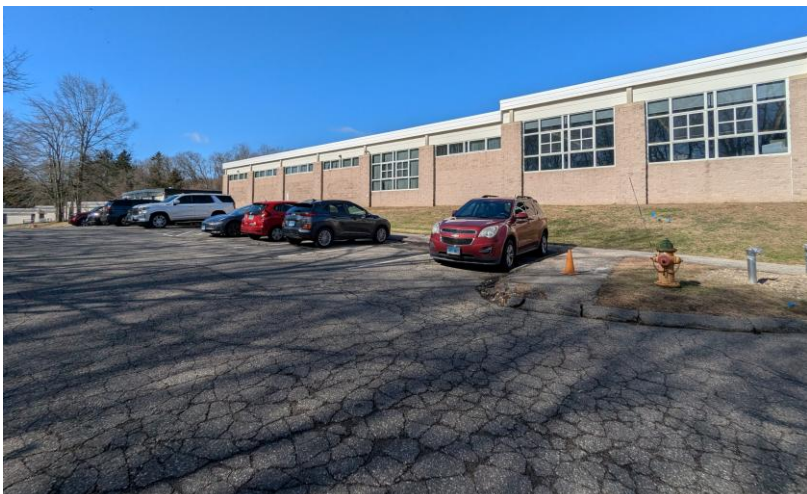
Visible alligator cracking in the paving. Mid-level parking lot.

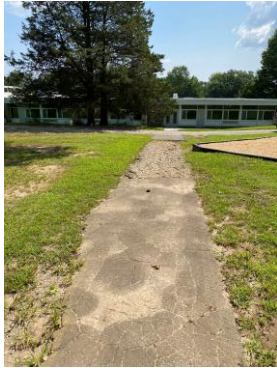
Asphalt-paved walking and car paths run along the perimeter of the school. These paths are generally in fair condition, but there are many areas with large cracks, and several areas worn down to gravel. Concrete walkways line the eastern perimeter at the drop-off zones and entrances, and are in good condition. New concrete sidewalks have been recently installed at the North Entrance.

Sidewalk in need of repair

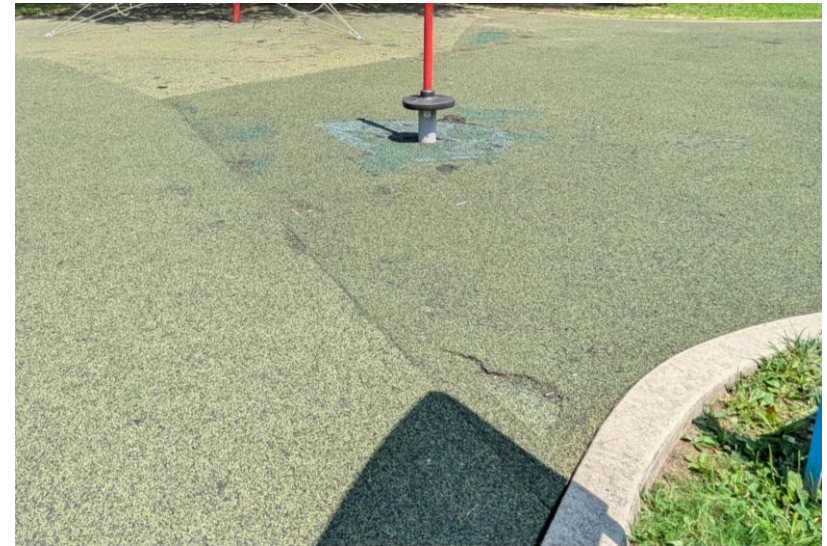
Playgrounds, baseball fields, and tennis courts are located to the west of the building. The playgrounds provide specialized equipment and swings on rubberized turf and wood mulch. The equipment appears to be in good condition, however the rubber surface is showing signs of wear and cracking. Some play areas are currently undergoing renovation.

Cracking and wear at rubber playground surface

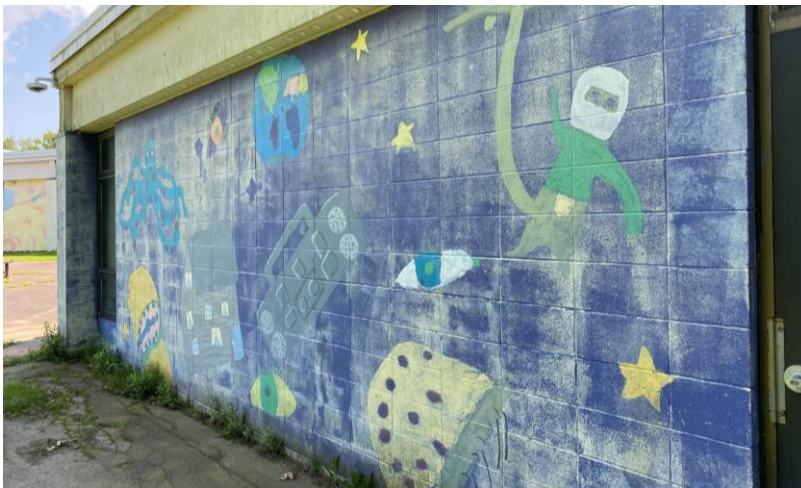
The west perimeter of the central node is adorned with colorful murals that brought color and creativity to the exterior walls. Over time, however, these works have lost their vibrance, now softened and faded, bearing the marks of age and weather.

Typical faded mural

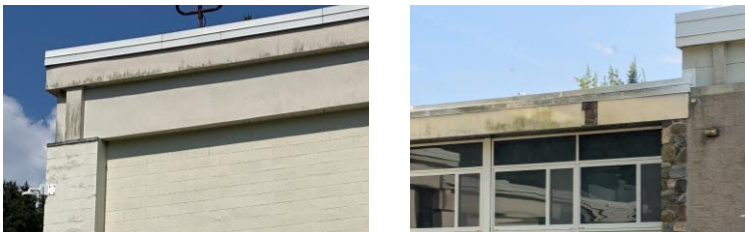
The fascia and frieze in various parts of the school exhibit noticeable dirt and staining, and require cleaning.

Examples of stained and dirty fascia and frieze

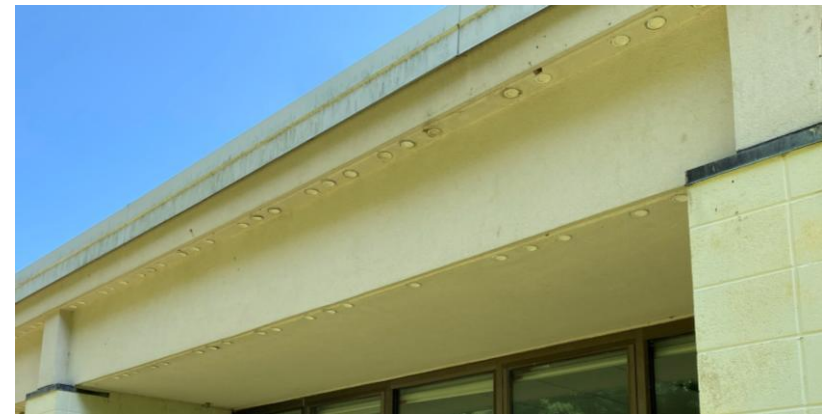
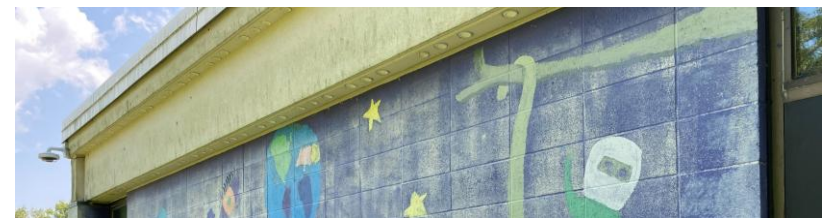
Soffit vents

A significant number of soffit vents are located along the perimeter of the 1970 additions. It is unclear how necessary these vents are, but they may represent a substantial source of heat loss. Additionally, the original detail for the eave shows a lack of insulation, providing an open thermal pathway from exterior to interior. The original details show vents only at the lower eave, but vents have since been added at the upper eave as well. Based on interviews with facilities staff, no vents have been added in the recent past. Facilities reported that the eaves are attractive to nesting insects.

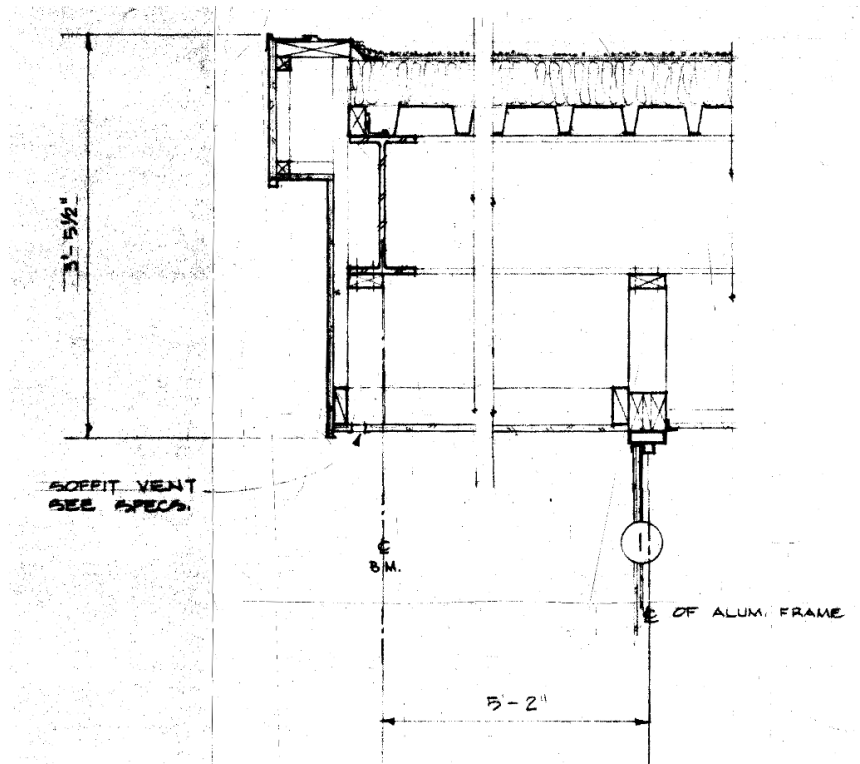
Original detail for 1970 additions showing uninsulated eave condition with significantly fewer soffit vents than exist currently.

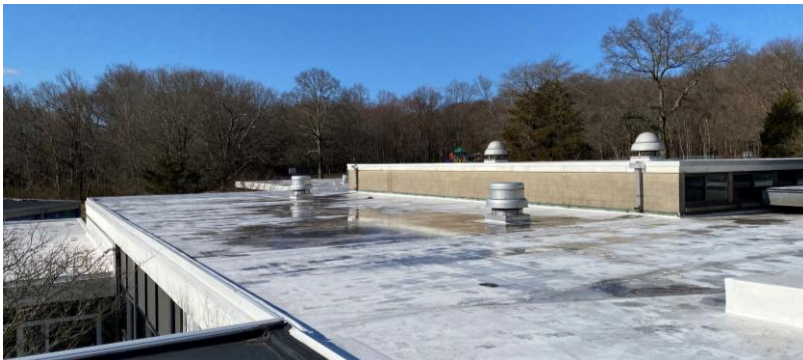
While the drains appear to be well maintained, ponding was noted in several locations on the 1960/64 portion of the roof. Based on interviews with WPS facilities, we understand that portions of the roof throughout the facility experience regular ponding due to insufficient or incorrect roof slopes.

Ponding water on the 1960/64 wing

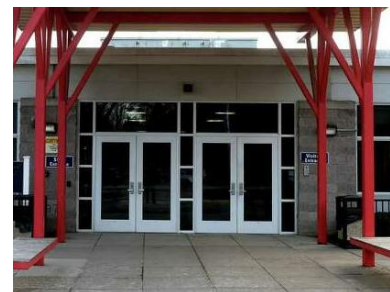
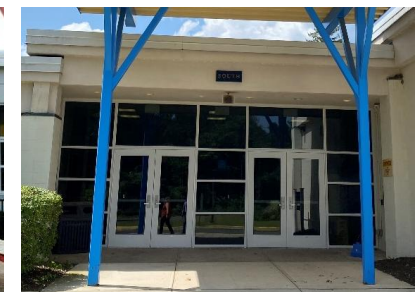
The exterior doors of the school vary in materials and conditions based on their locations and the periods of construction. The North entrance doors, made of glass and aluminum, were installed during the 1997 addition/renovation and are in good condition, however, at nearly 30 years old are nearing the end of their useful life. Similarly, the South entrance doors, also glass and aluminum, are well maintained and in good condition, though their installation date is unknown, but precedes the 2016 renovation. If they were installed over 20 years ago, they too are approaching the end of their useful life.

Aluminum and glass doors at North and South entrances.

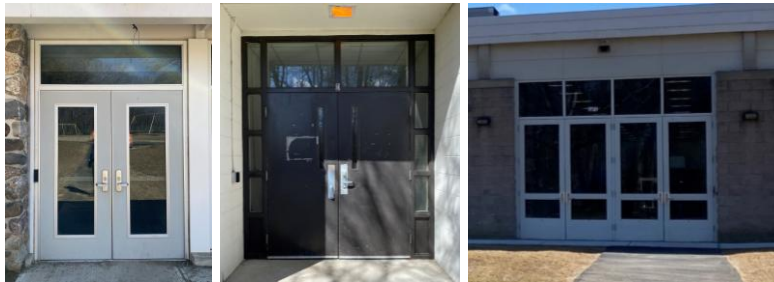
addition has insulated metal panel doors with a single vision lite which pre-date the 2016 renovation, and are near the end of their useful life. The aluminum and glass doors in the 1997 addition are in good condition but are original to the building and approaching the end of their service life.

FRP and glass doors Hollow metal doors, 1970 Aluminum and glass doors, 1997

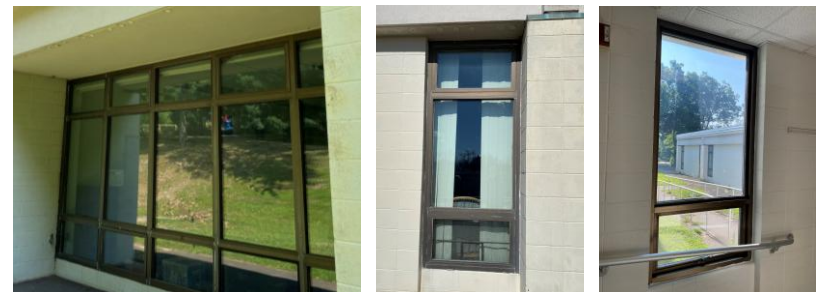
The 1970 addition has bronze anodized aluminum storefront windows with fixed panes and awnings above and below. They are in fair condition; frames are chipped, scratched, and faded, and caulking appears to be failing. These windows are near the end of their useful life.

Typical windows at the 1970 addition

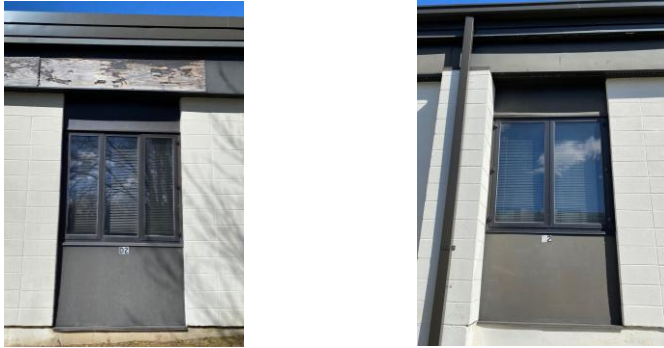
casements. These windows appear to be original to the construction and are nearing the end of their useful life.

Typical windows at the 1994 addition

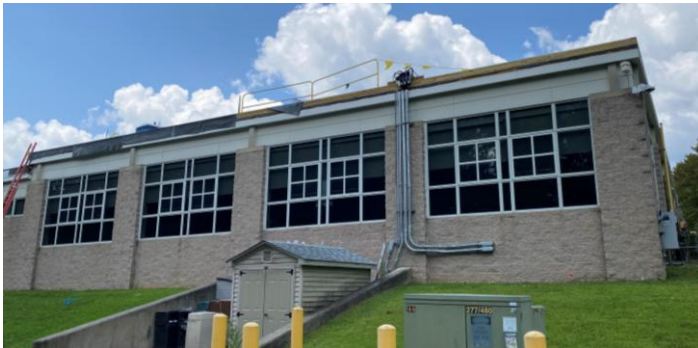
The 1997 addition has white aluminum storefront windows with hopper windows framed by fixed insulated glass and insulated metal panels below. These windows are original to the construction and, while in good condition, are nearing the end of their useful life.

Typical windows at the 1997 addition

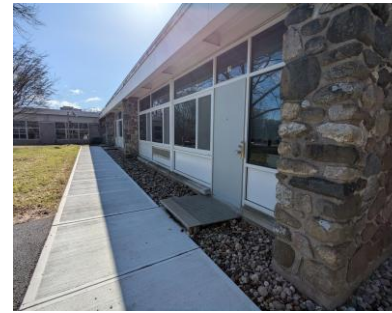
Most of the school's entrances are at grade level. However, it was observed that the exterior doors to several classrooms in the 1960/64 section of the building lead to a small landing with a step down to the ground. While this step is considered acceptable as a secondary means of egress according to

the building code, the height of the landing exceeds the maximum allowable limit at several locations.

Landing and step at classroom doors to exterior 1960/64 door.

Landing and step at classroom door riser height exceeds code requirements

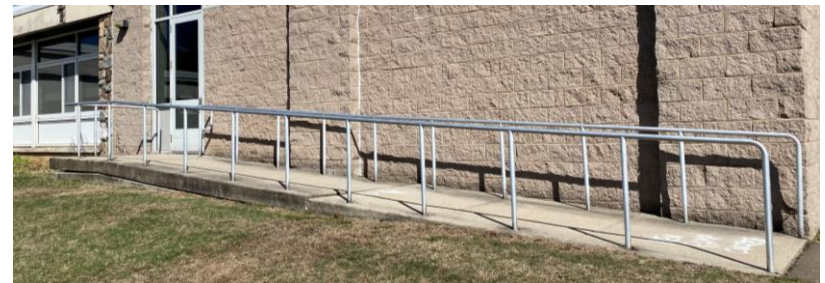
The sidewalks around the perimeter of the school connect to several ramps, providing wheelchair access to various areas of the building. The slope of these ramps typically appeared to meet current accessibility regulations. However, the handrails are not ADA compliant because they lack extensions on the top and bottom of runs, and they also lack bottom rails or curbs to prevent a wheelchair from catching on a post. Concrete ramps also show signs of heaving at control joints, causing tripping hazards.

Non-compliant ramp at the Library

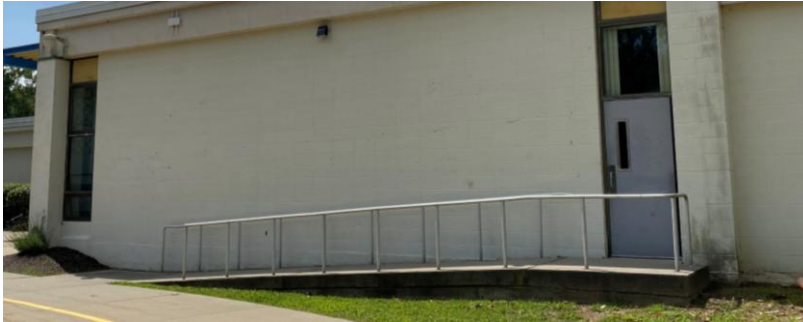
Non-compliant ramp at the South Assembly

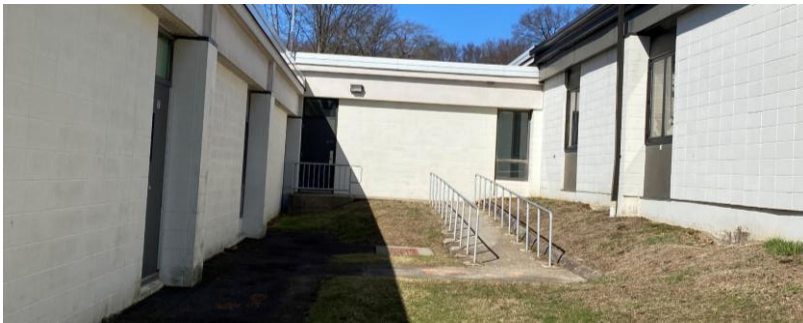
Non-compliant ramp between the 1970 and 1994 addition

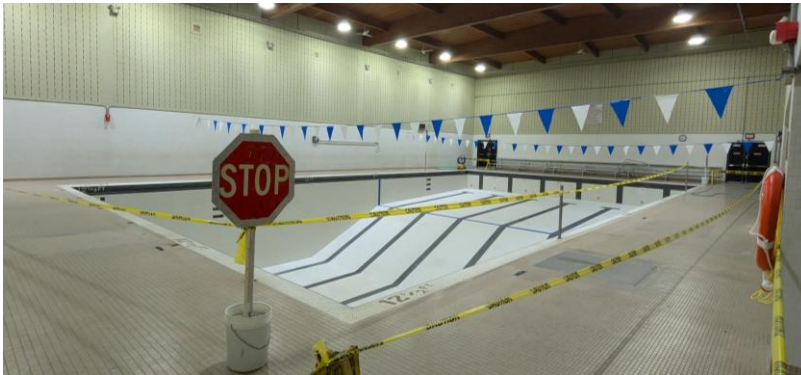
The pool is located in the 1970's portion of the building near the south entrance. Previously considered a valuable community asset, the pool was utilized by local programs and the school system. However, it is currently

closed due to rising operational costs and the expenses associated with necessary repairs.

Pool

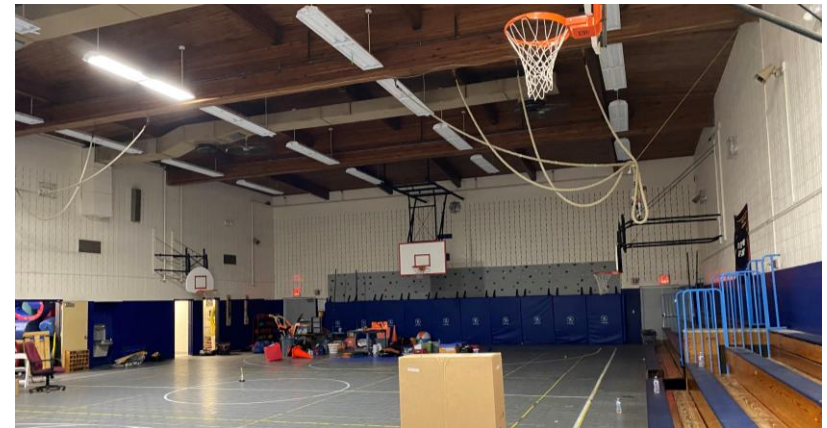
The South Gymnasium is situated in the 1970's portion of the building, adjacent to the pool, and is approximately 5,000 square feet. It features multiple basketball hoops with a full-size court and telescopic wooden bleachers, which are in fair condition. The modular tile flooring system is durable and easy to maintain, however the striping has faded and, deteriorated from wear and tear. Additionally, the gym includes several equipment storage closets and an office directly off the main space, offering functional support for sports and other activities.

South Gym

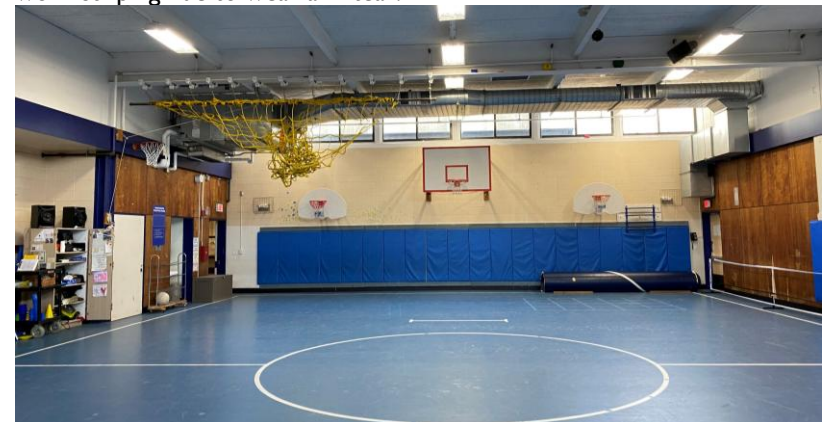
Located in the original 1960/64 portion of the building, the North Gymnasium is approximately 3,200 square feet. It features multiple basketball hoops, with two positioned in standard locations and others placed awkwardly near doors or mechanical equipment. While the ceiling is notably high, large HVAC equipment and ducts at the north and south ends of the gym limit the height. The wood panel walls, though functional, are scratched and dated in appearance. The gym includes several small equipment closets but lacks office space directly connected to the area. Its synthetic flooring remains in fair condition but exhibits scuff marks and worn striping due to wear and tear.

North Gym

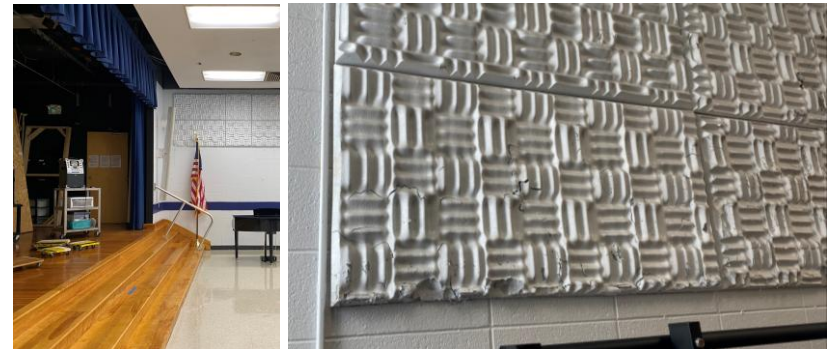
corridor. The South Assembly Room's CMU walls are lined with acoustic panels, though these panels are cracked and chipping, indicating a need for maintenance or replacement.

South Assembly stage area Typical acoustic wall panel

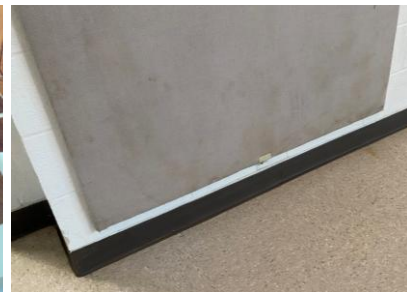
The Multi-Purpose Room is centrally located within the building and is approximately 1,700 square feet in size. This hexagonal-shaped room is designed to support multiple classes or groups at the same time, making it an ideal venue for various school activities, such as group gatherings, presentations, and events. The room's unique cupola-like ceiling features clerestory windows that allow natural light to fill the space. The wood plank ceiling is in good condition, with no obvious issues. The room's painted CMU walls are lined with acoustic panels that have become dull, stained, and worn over time.

Stained acoustic wall panel

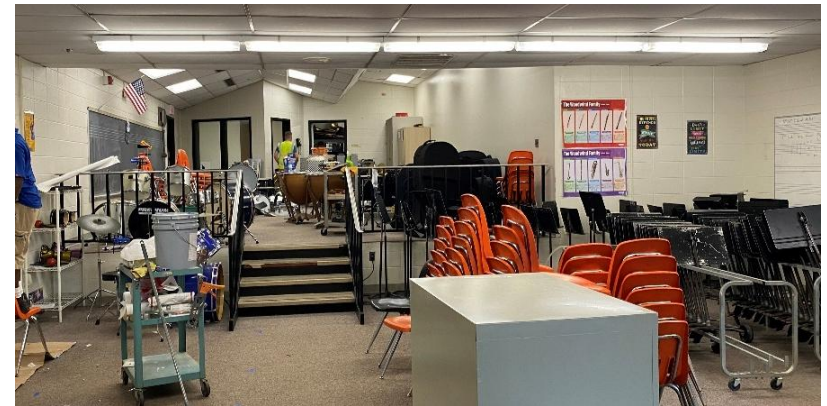
View of the Music Room

The room lacks acoustic features essential for a space dedicated to music instruction. The ACT ceiling is sagging, stained, and dated in appearance, suggesting the need for repair or replacement. Carpet flooring is torn in multiple locations and the vinyl treads on the steps are chipped and broken. The space does not provide adequate storage options for musical instruments or equipment.

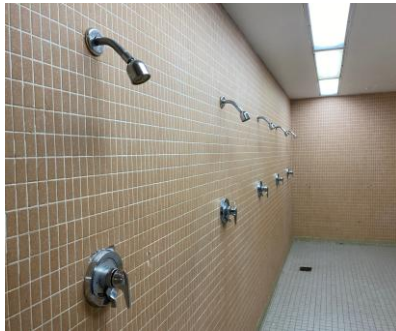
Shower area

The floor and wall tiles are undamaged, however, the grout is often stained, and the tiles have a dated appearance that may benefit from aesthetic updates. The gypsum board ceiling is mostly in good condition, but areas of water damage have been noted, indicating the need for repairs or further evaluation.

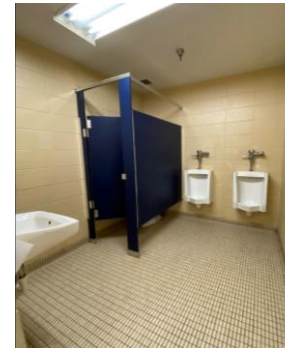
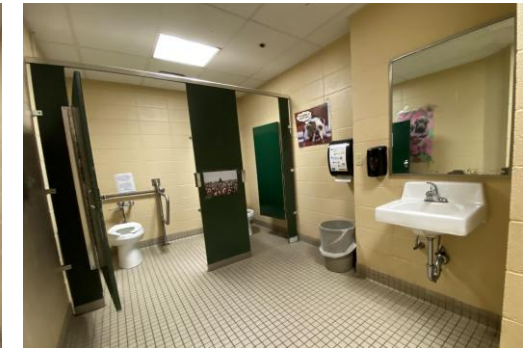
Typical 1970's ganged toilet

The 1970s addition includes mostly ganged toilet rooms. Several single-user toilet rooms were also installed for staff use. ADA-accessible stalls are present in the ganged facilities and include proper clearances and grab bars. Fixtures in this section are typically standard-height, floor-mounted toilets and wall-mounted sinks. No major functional issues were observed. Flooring throughout these restrooms is tile, but like the earlier additions, the surfaces appear worn and faded, and the grout is dirty.

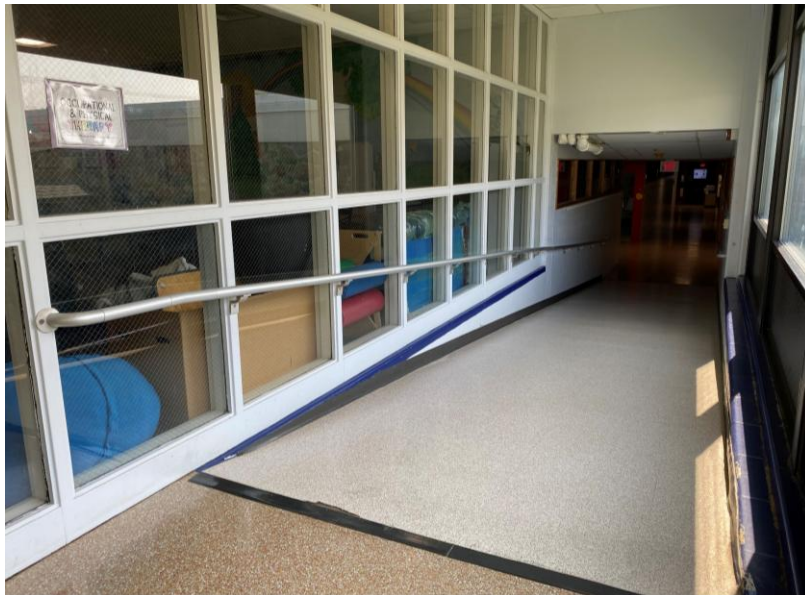
Ramp outside the Commons/North Gymnasium

Although vertical circulation is limited due to the building's single-story design, elevation changes are managed via a series of ramps located within extended corridor runs. Most ramps appear to meet the maximum slope requirement of 1:12 (approximately 4.76°); however, a few exceed this threshold and may warrant further evaluation. Handrails are generally compliant with ADA guidelines, though some ramp segments lack the required 12-inch horizontal extension at the top and bottom landings. Staircases are minimal and primarily located in service areas providing access to mechanical rooms and storage. These stairs are constructed to code, with compliant risers, treads, and handrails.

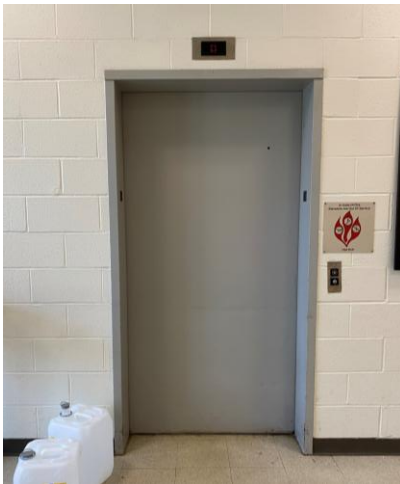
Elevator

The existing elevator is a Thyssenkrupp model and appears to be original to the construction of the 1997 addition. Given that the typical service life for an elevator is approximately 20 to 25 years, this unit is approaching the end of its expected operational lifespan and should be considered for an upgrade in the near future.

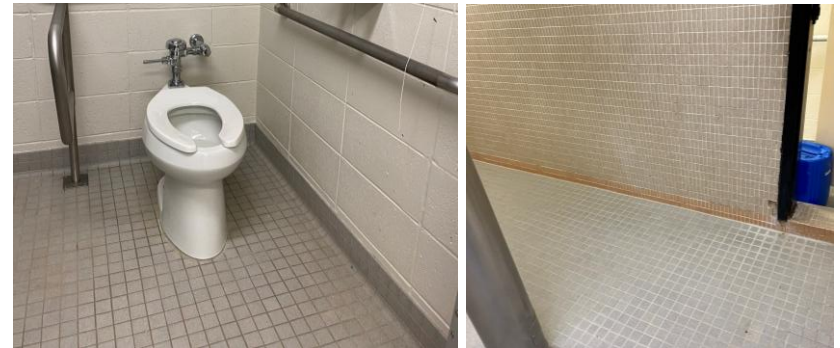
In the pool area, adjacent locker rooms, and multiple toilet rooms, the tile flooring and grout are in fair condition. These materials appear original to the 1970s construction and show signs of aging, including fading and staining.

Typical tile flooring at toilet rooms and locker rooms

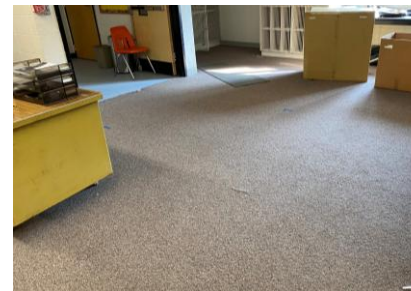
In the Music Room, the carpet exhibits multiple tears and is both stained and faded. Vinyl stair treads in this area are chipped and cracked, indicating the need for replacement or repair.

Music Room carpet

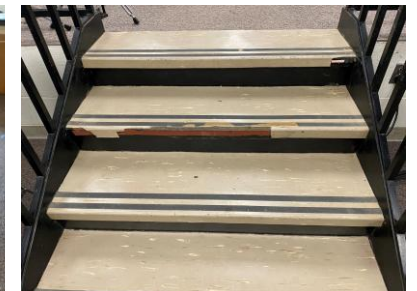
Music Room vinyl steps

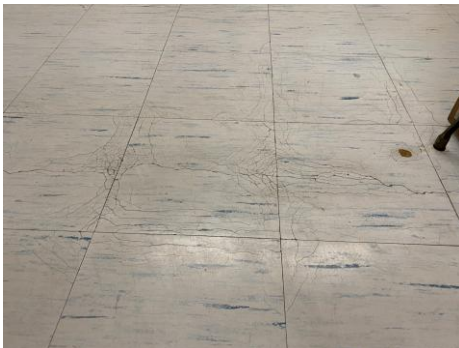
Vinyl composition tile (VCT) is the predominant flooring type found in classrooms and hallways. While generally well maintained and in good condition, the VCT appears dated. Notably, in the 1994 addition, several areas of VCT were observed with cracking and signs of wear.

Cracked VCT in the 1994 addition

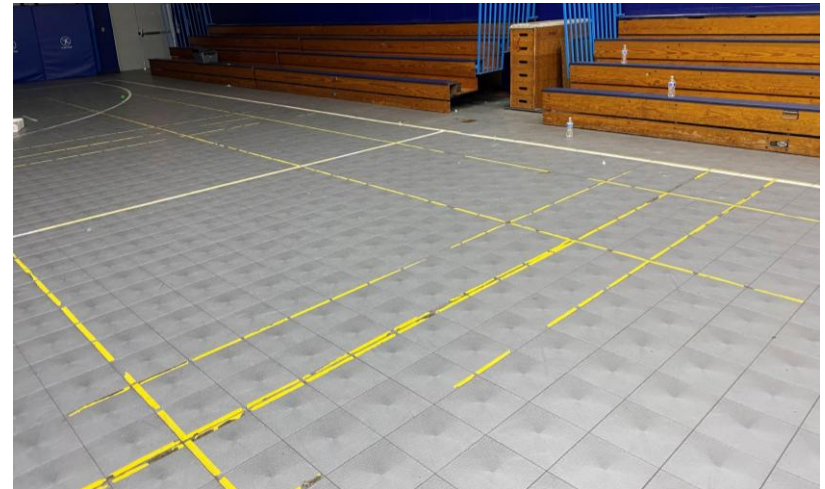
The South Gymnasium features a modular tile flooring system, which is in good condition overall. However, the game line striping is significantly faded and worn. Similarly, the North Gymnasium has a synthetic flooring system that is also in good condition, but like the South Gym, its striping is faded and shows signs of wear.

South Gym tile floor system

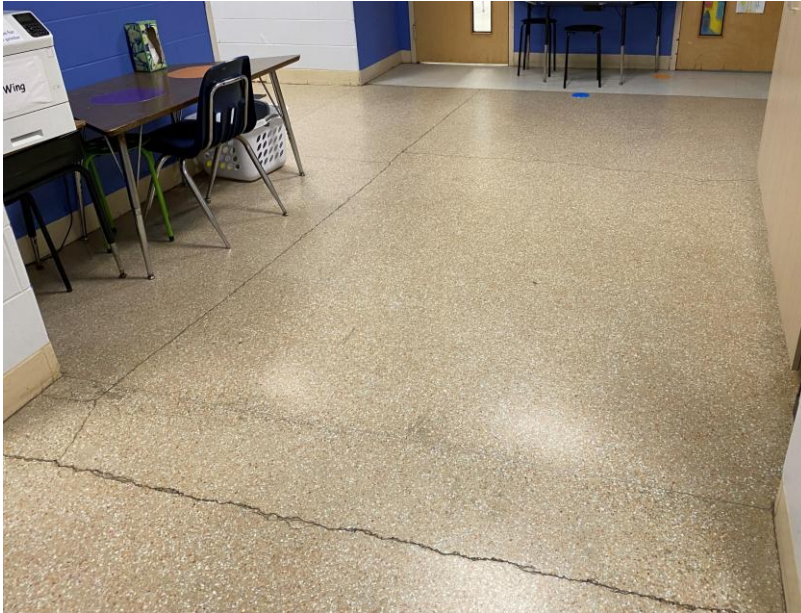
Corridors in the original 1960/64 portion of the building are finished with terrazzo flooring. While this material is durable, multiple cracks were observed, placing it in fair condition.

Cracked terrazzo flooring, 1960/64 portion of the school

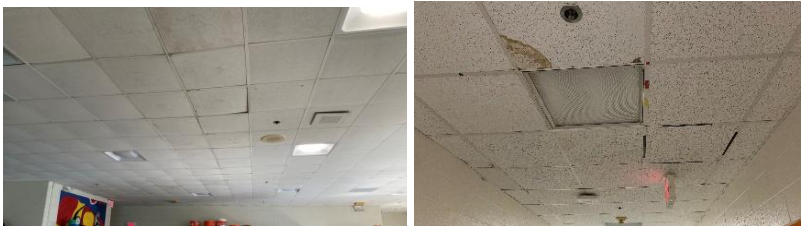
Overall, ceilings are generally in good condition; however, areas of water damage were noted, and further investigation is recommended to determine whether the source is mechanical equipment failure or active leaks in the building envelope.

Dirty and sagging ceiling tiles

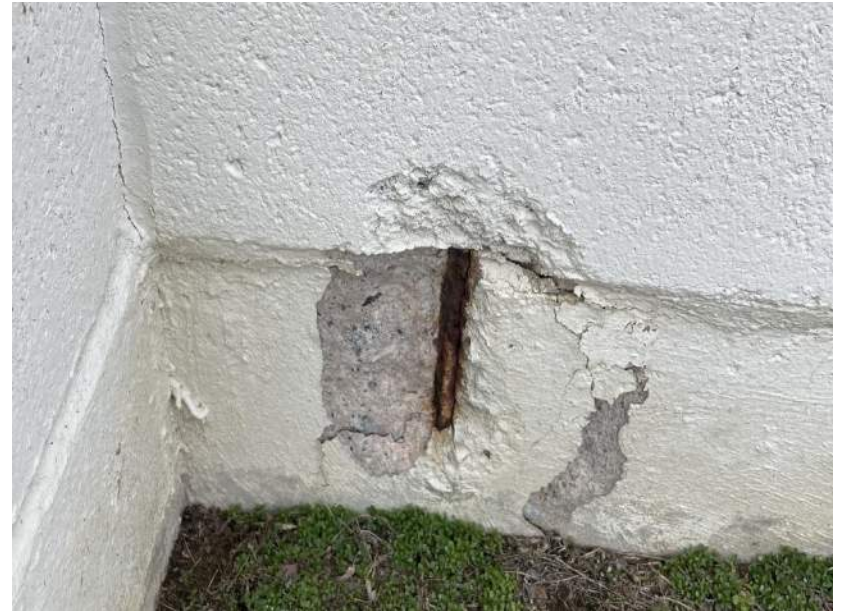
- Cast in place concrete foundation frost walls with cracking observed throughout, and in some cases, exposed reinforcing. This was observed predominantly in the 1960 and 1970 portions of the building, but also in the connecting corridors, and the 1994 addition, refer to Exhibits #1 thru #6.
- Exposed aggregate in the concrete foundations and delamination was observed around the 1960 portion of the building foundation, at multiple areas. Refer to Exhibits #7 and #8.

Exhibit #2: Exposed reinforcing

- The overall concrete foundation and slab on grade were observed to be in fair condition. The observed conditions are consistent with a building of this age. Efforts should be taken to continue to keep rain water away from the perimeter of the building. The deficiencies noted should be repaired to prevent further deterioration and potential failure.

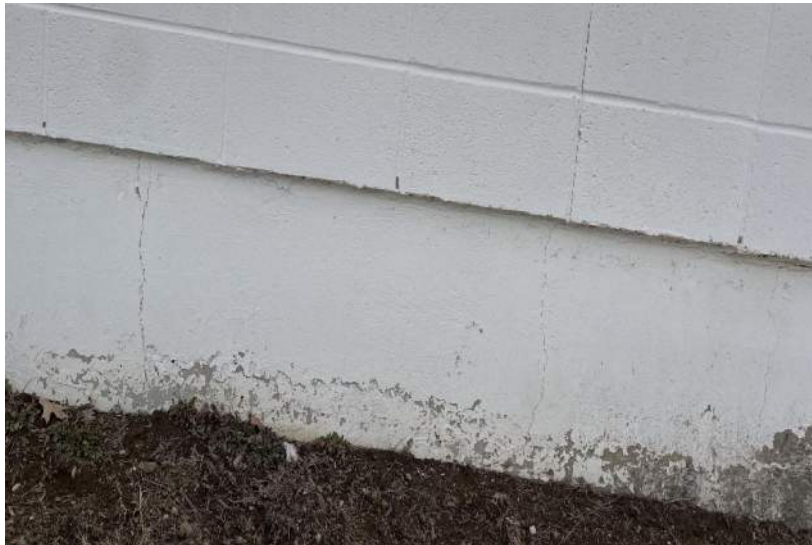
Exhibit #1: Foundation Cracks Typical

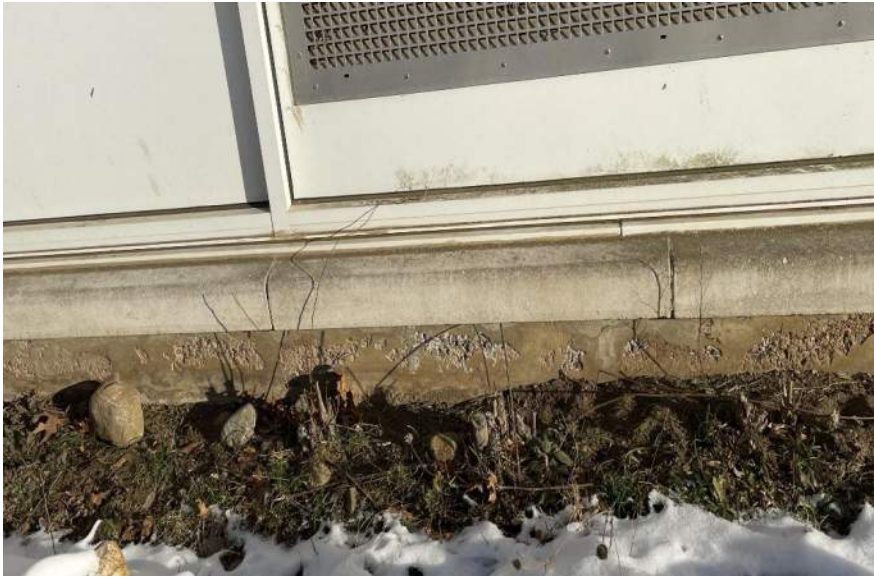
Exhibit #7: Exposed aggregate and deterioration

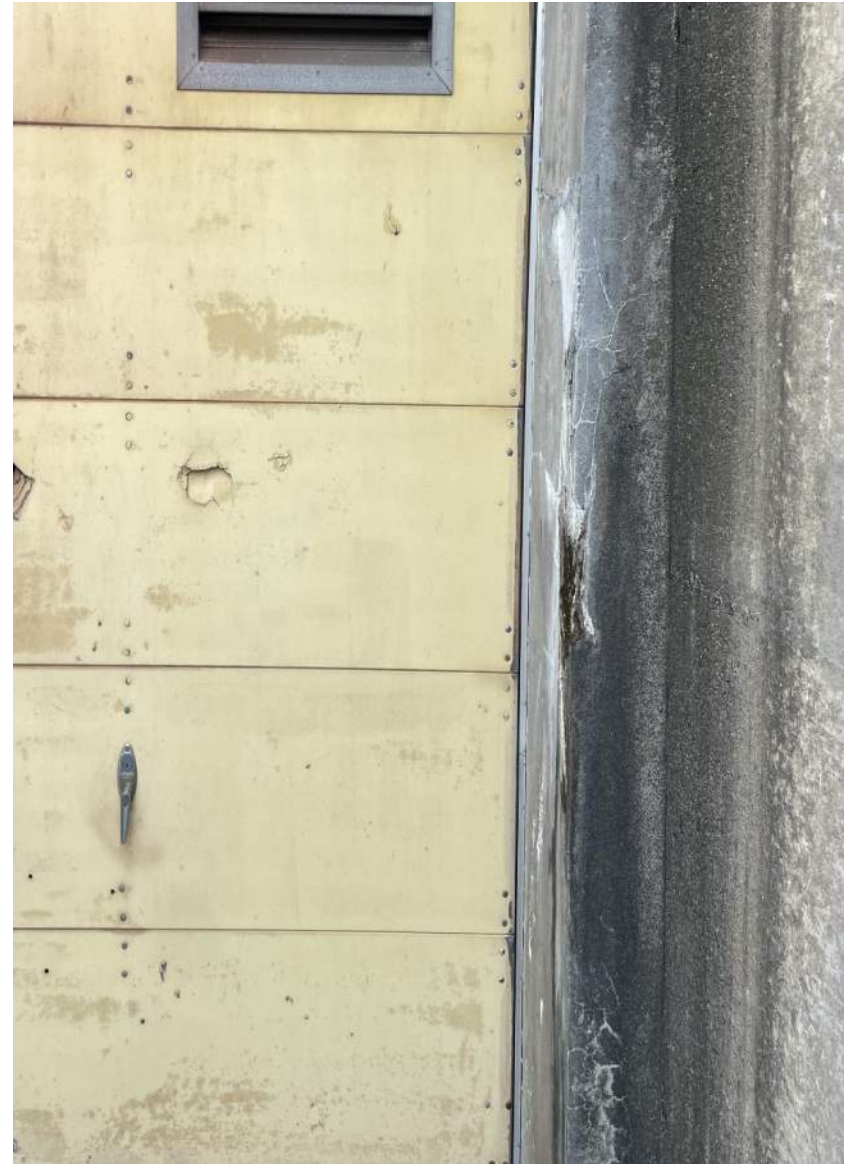
Exhibit #9: Severe cracking and delamination

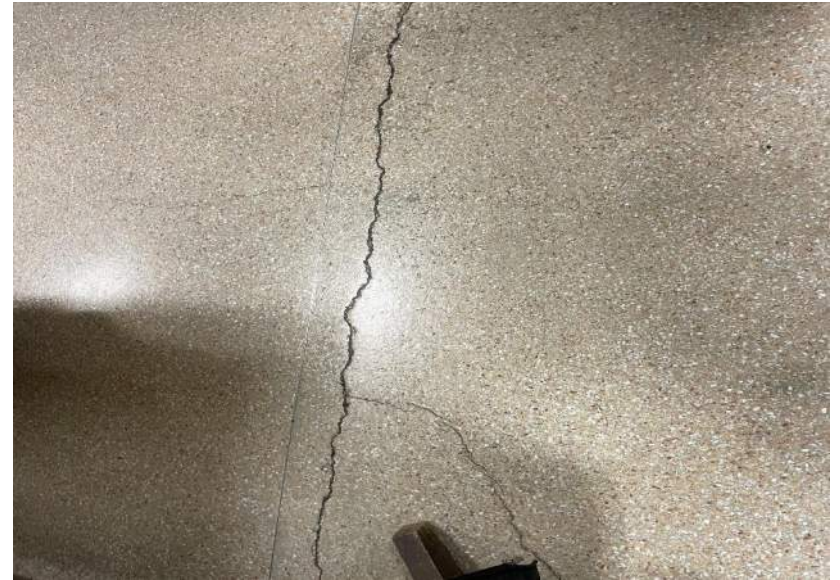
Exhibit #11: Cracking and heaving at slab on grade

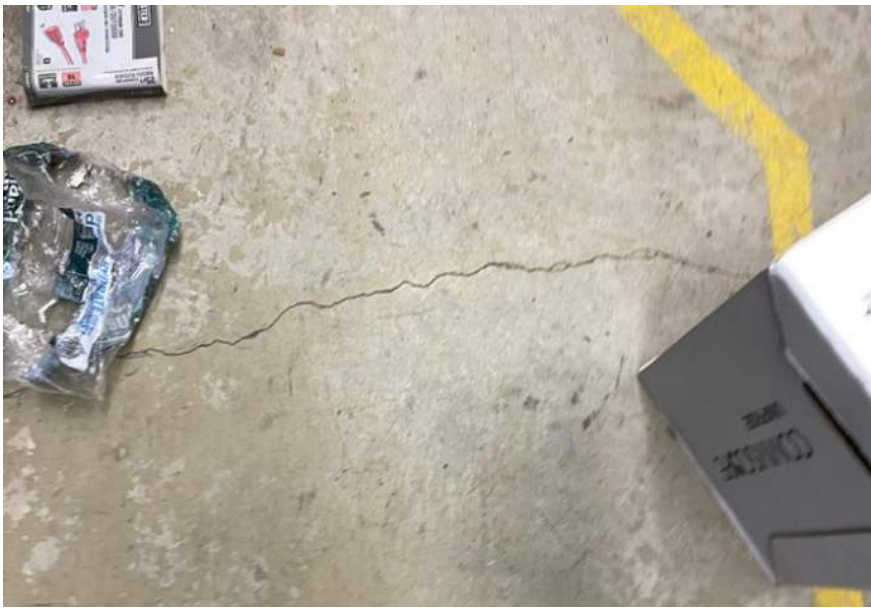
Exhibit #14: Slab on deck cracking at mechanical room

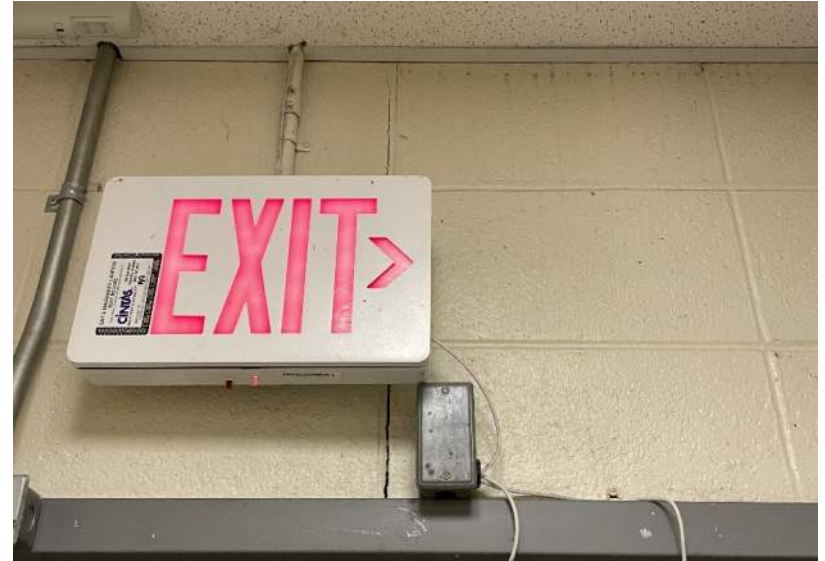
Exhibit #17

- Cracking was observed in the CMU wall at various areas of the building, both interior and exterior. Refer to Exhibits #15 thru #21.
- Severe spalling and separation were observed at the CMU pilaster at the rear of the pool area. Refer to Exhibit #22.
- The exposed portions of the structural frame (timber and steel) did not exhibit any significant signs of distress or deterioration. Areas of the steel frame are exposed to the elements at exterior overhang of the 1960 portion of the building and exhibited slight signs of surface corrosion. Refer to Exhibit #23.
- Surface corrosion was also observed at the base of canopy steel column at the entrance. Refer to Exhibit #23.

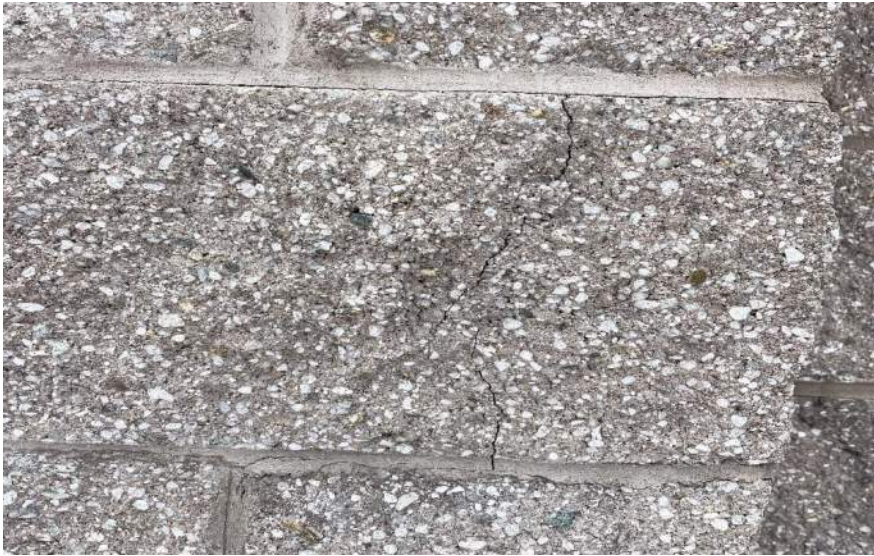
Exhibit #19: Cracking at split face CMU (typical)

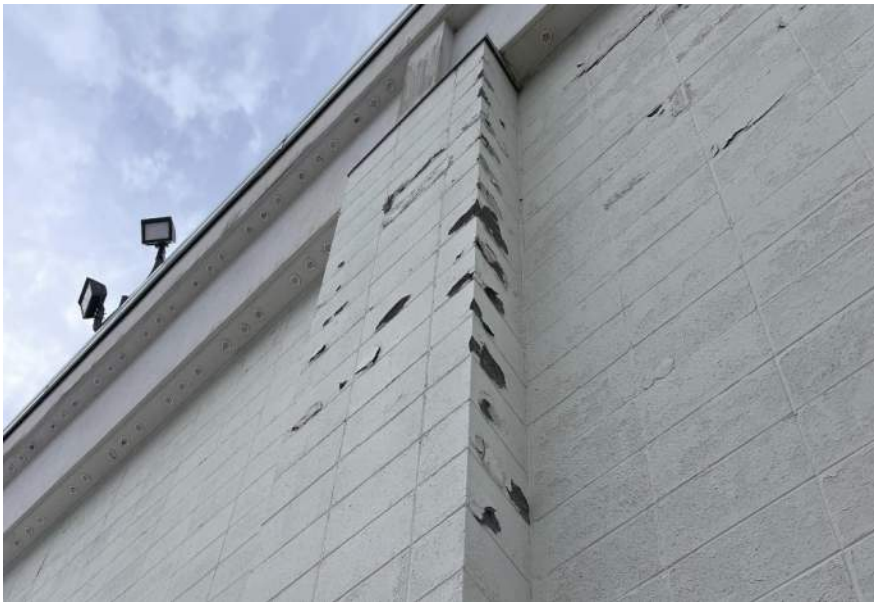
Exhibit #20: Spalling and separation of CMU at pool

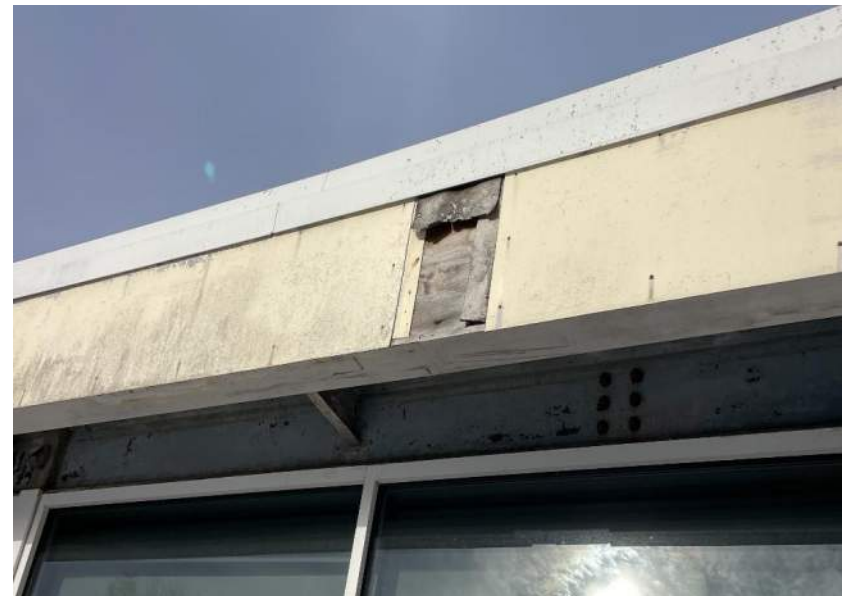
Exhibit #22: Exposed steel at soffit

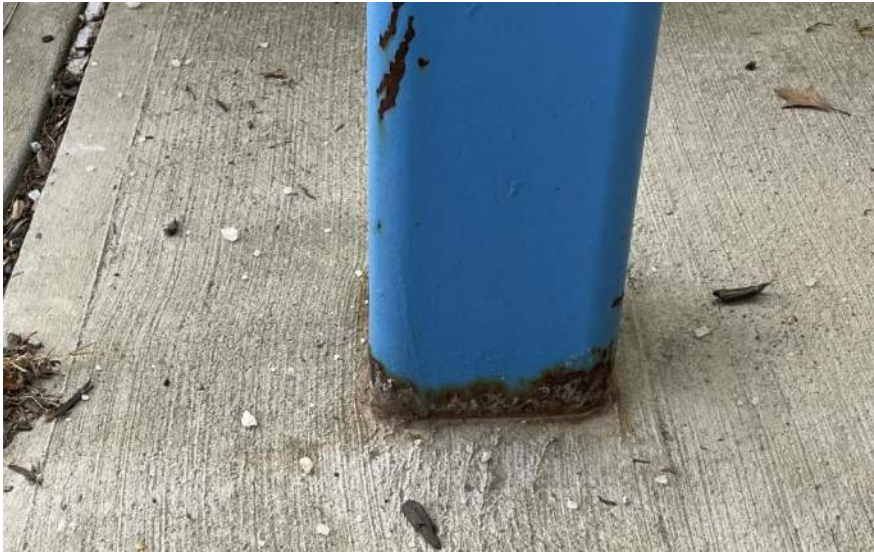
Exhibit #23: Surface corrosion at base of canopy column

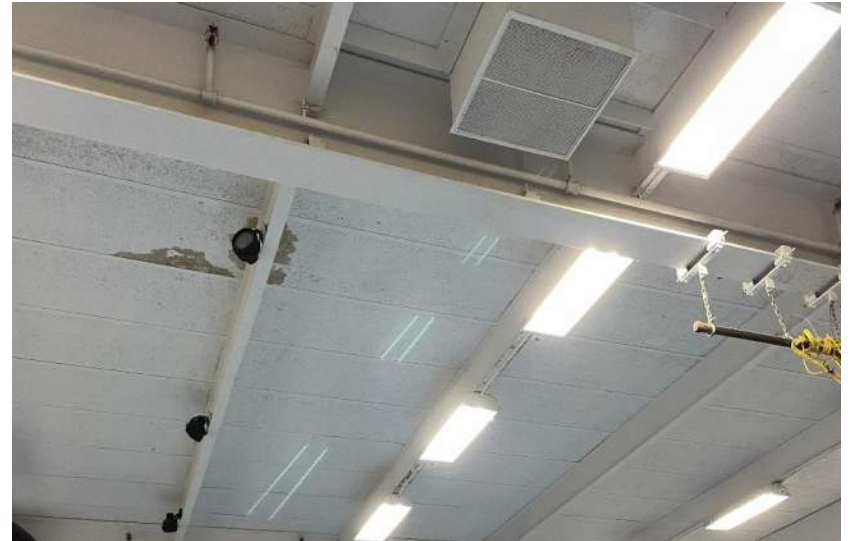
Exhibit: 25

- Interior ceiling areas exhibited signs of water infiltration in some areas. Refer to Exhibit #24 and #25.

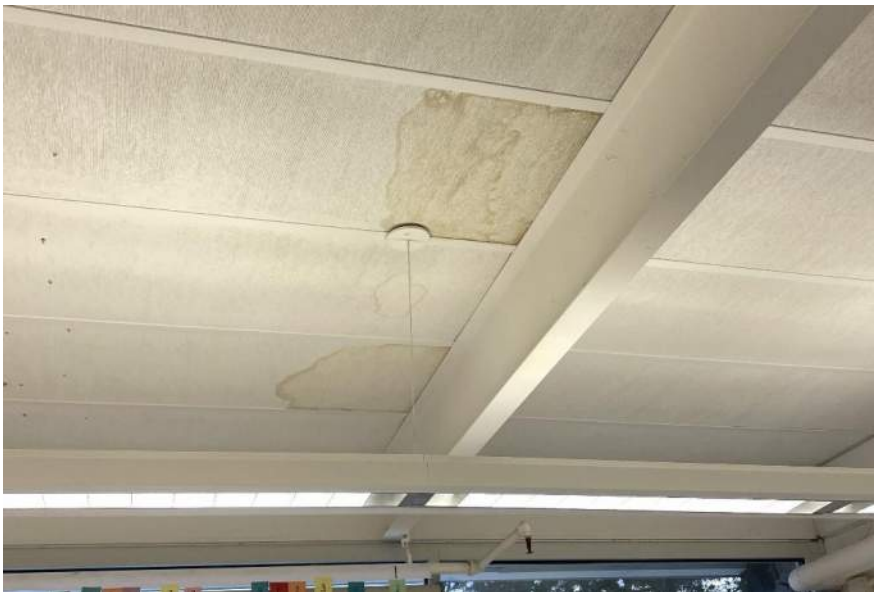
Exhibit #24: Interior water damage (typical)

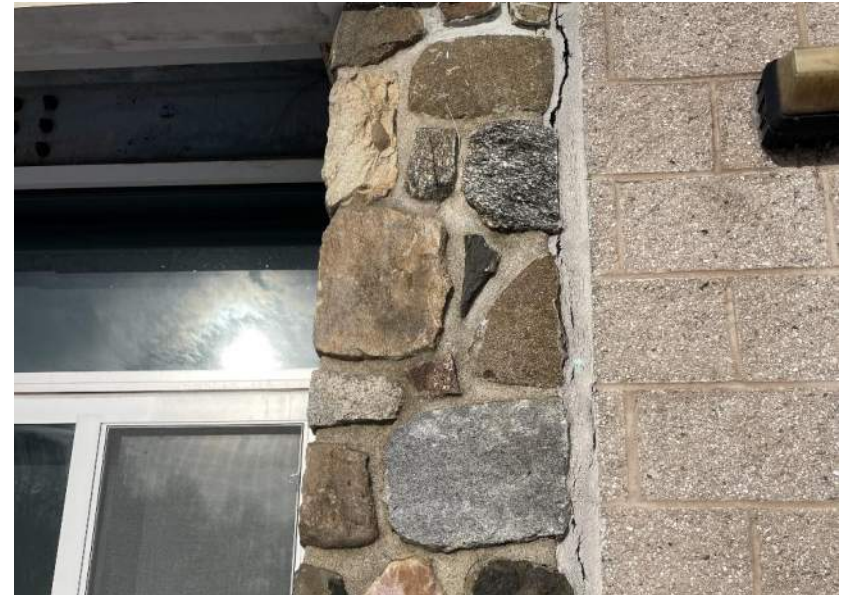
- Deterioration of exterior joints fillers and waterproofing was observed in several areas which will lead to water infiltration and eventually compromise the structural integrity of components. Refer to Exhibit #26 and #27
- Exterior finishes: Deterioration and damage was observed, including exposed wood and EIFS at the exterior soffits in several areas of the building. Refer to Exhibit #28 and #29.

Exhibit #26: Joint sealant failure (typical)

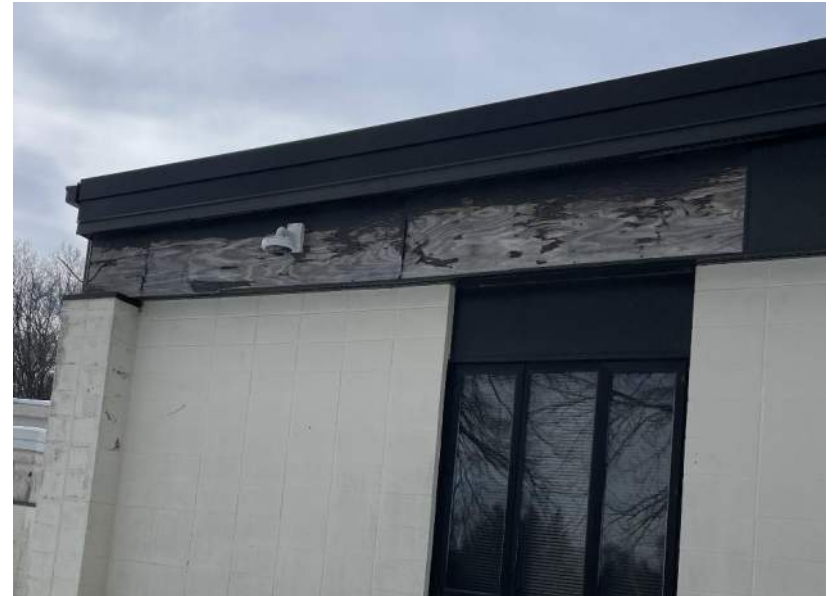
Exhibit #28: Exposed sheathing at soffit
