BEECHER ROAD ELEMENTARY SCHOOL

EXISTING FACILITY CONDITION ASSESSMENT | 40 BEECHER ROAD, WOODBRIDGE, CT

March 4, 2026

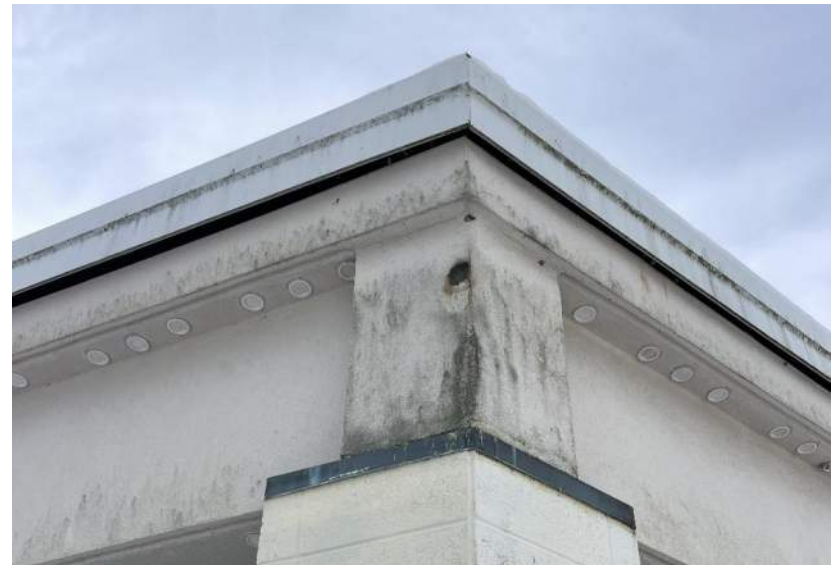
- Deterioration of exterior joints fillers and waterproofing was observed in several areas which will lead to water infiltration and eventually compromise the structural integrity of components. Refer to Exhibit #26 and #27
- Exterior finishes: Deterioration and damage was observed, including exposed wood and EIFS at the exterior soffits in several areas of the building. Refer to Exhibit #28 and #29.

Exhibit #29: Damaged EIFS (typical)

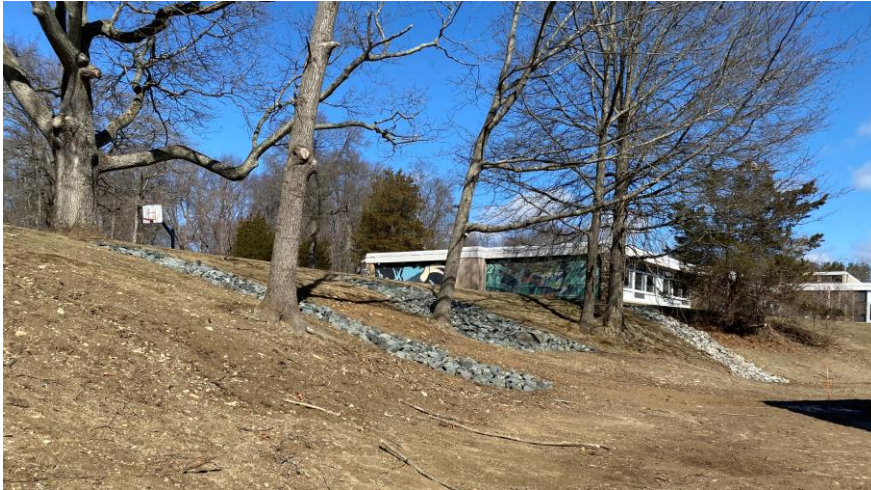
Evidence of regular maintenance: new riprap at grade change

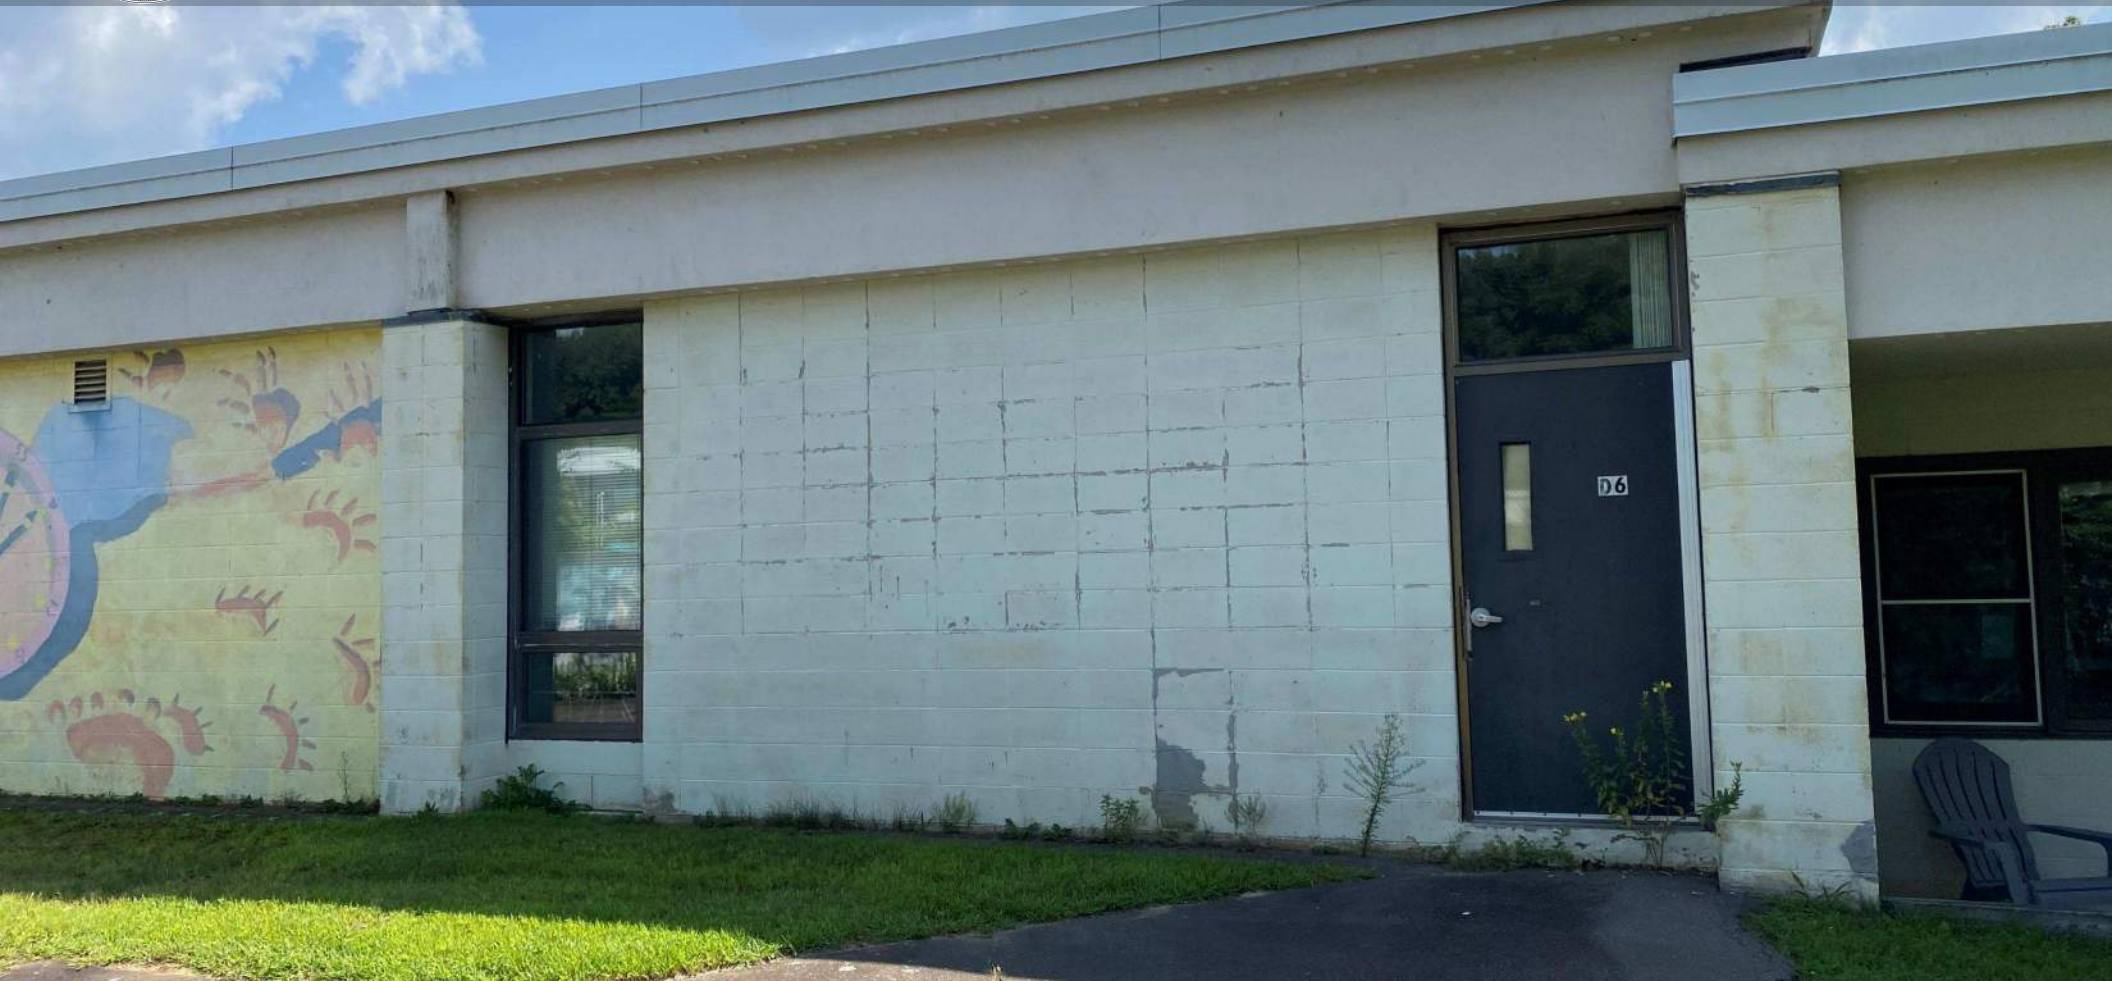
Worn Facades – Inadequate Insulation, Thermal Bridging

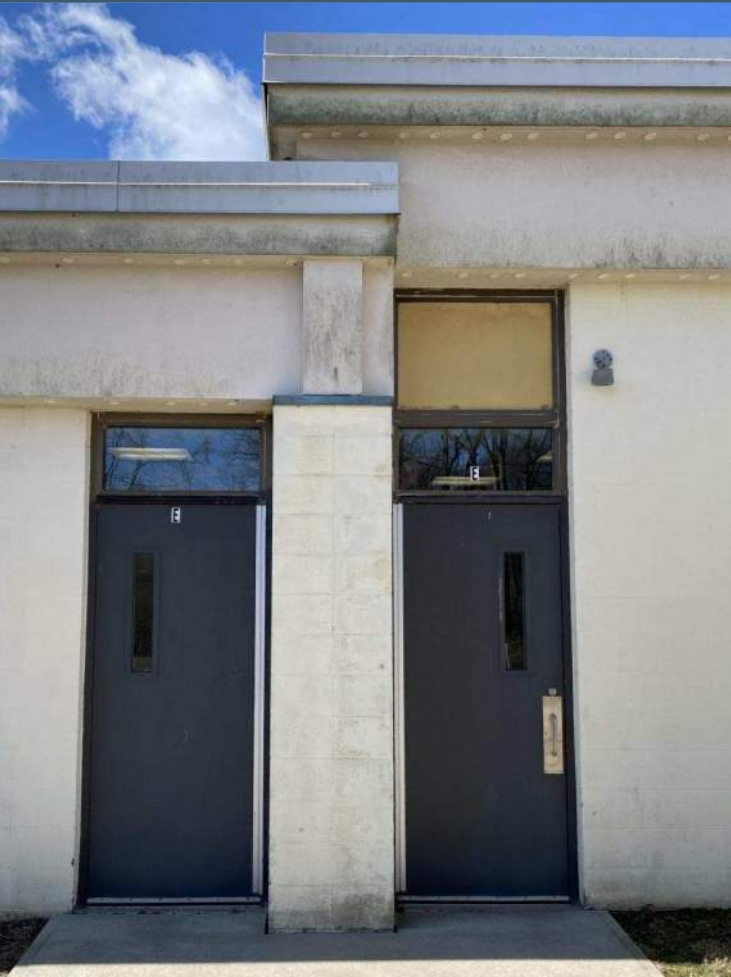
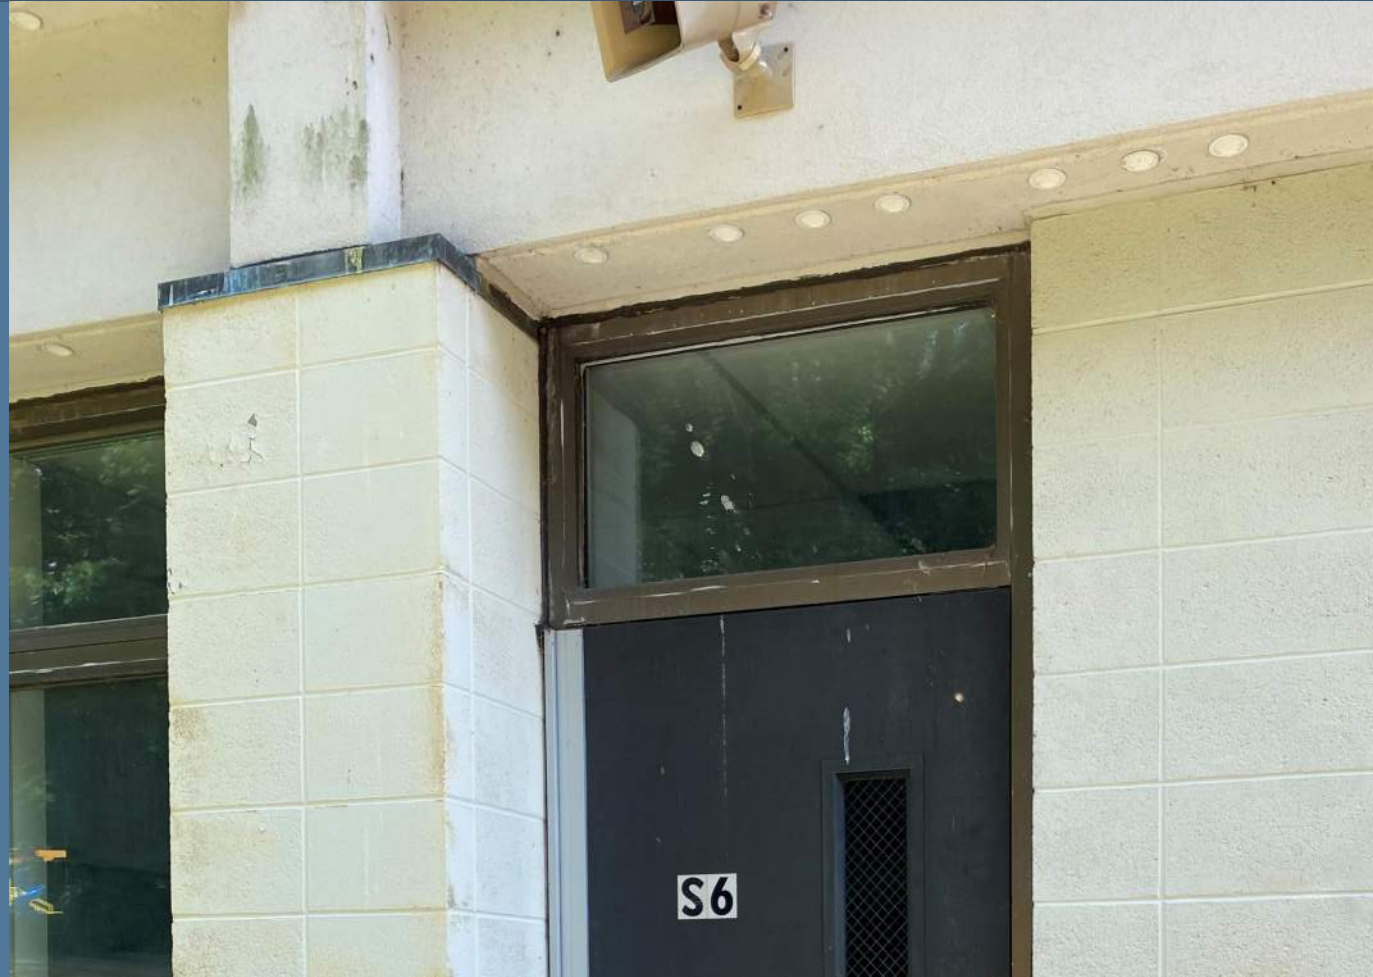
Worn Facades – Inadequate Insulation, Thermal Bridging

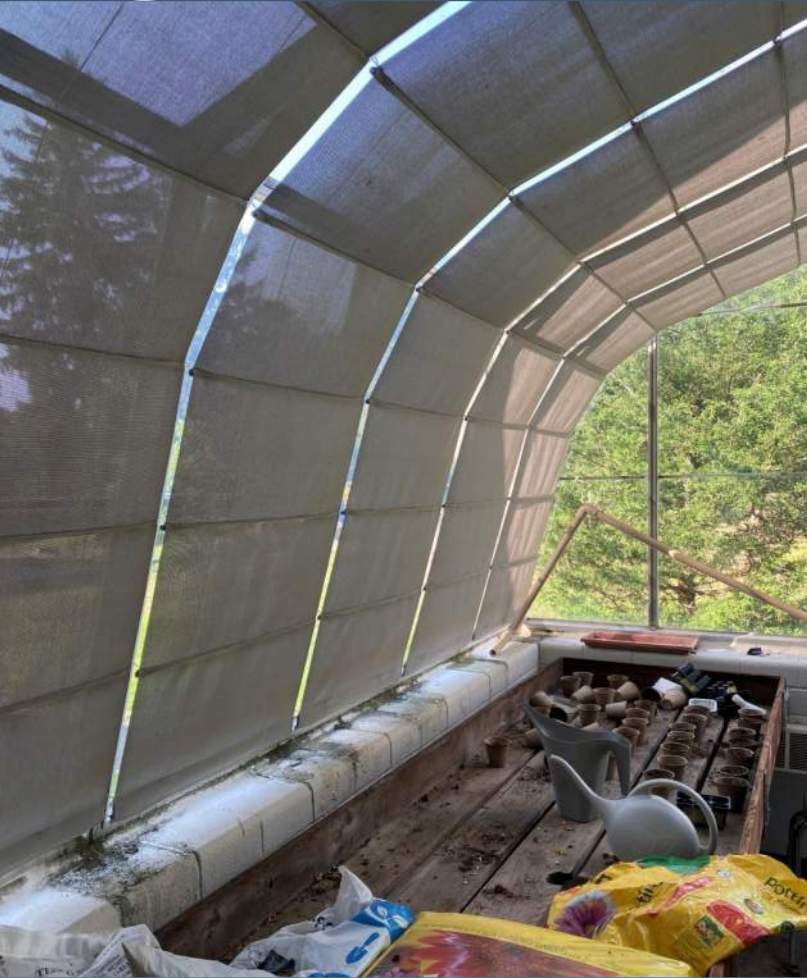
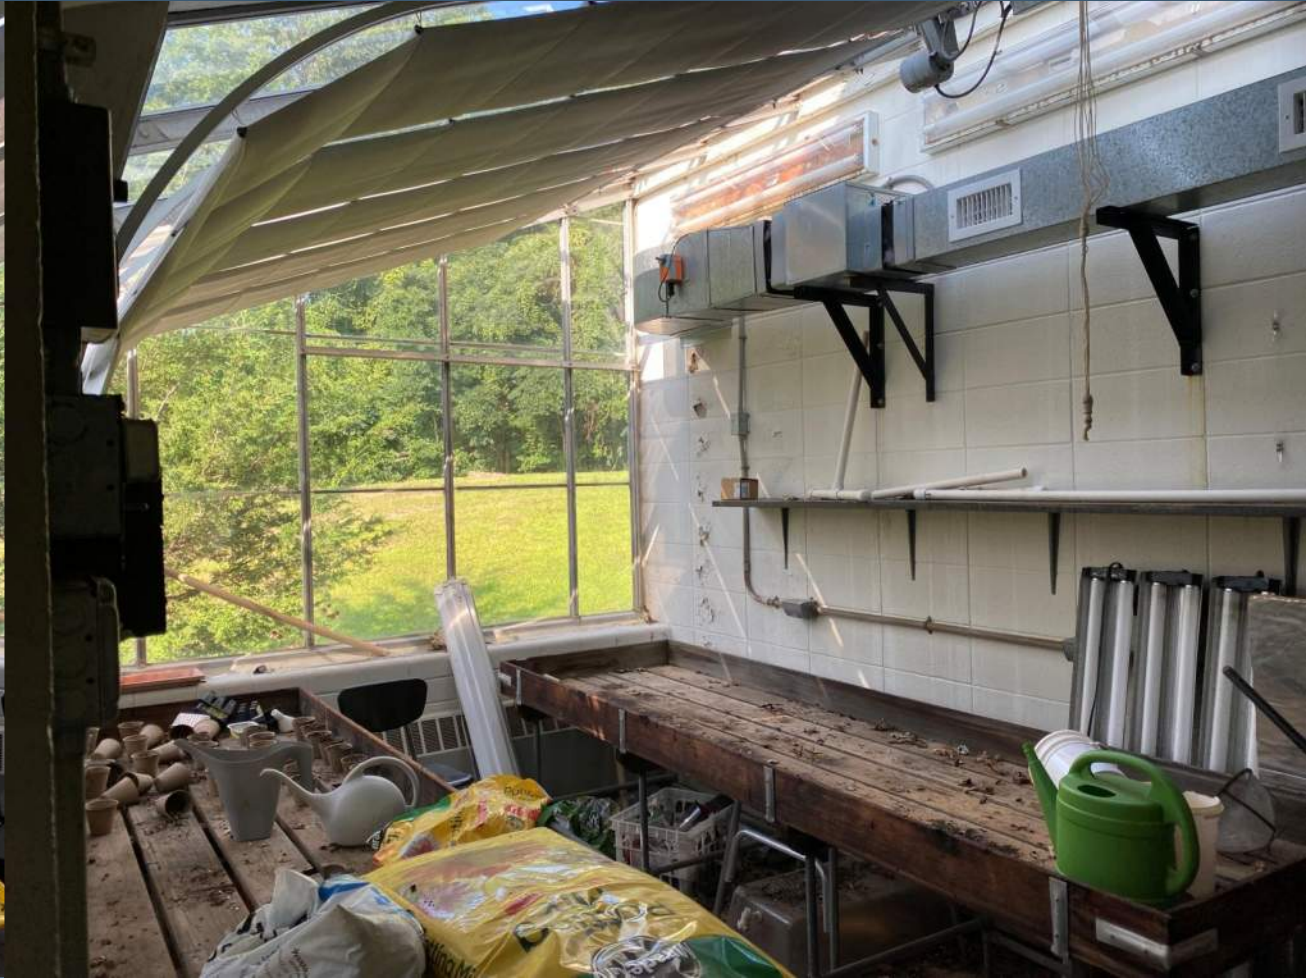
Greenhouse: Repairs Required

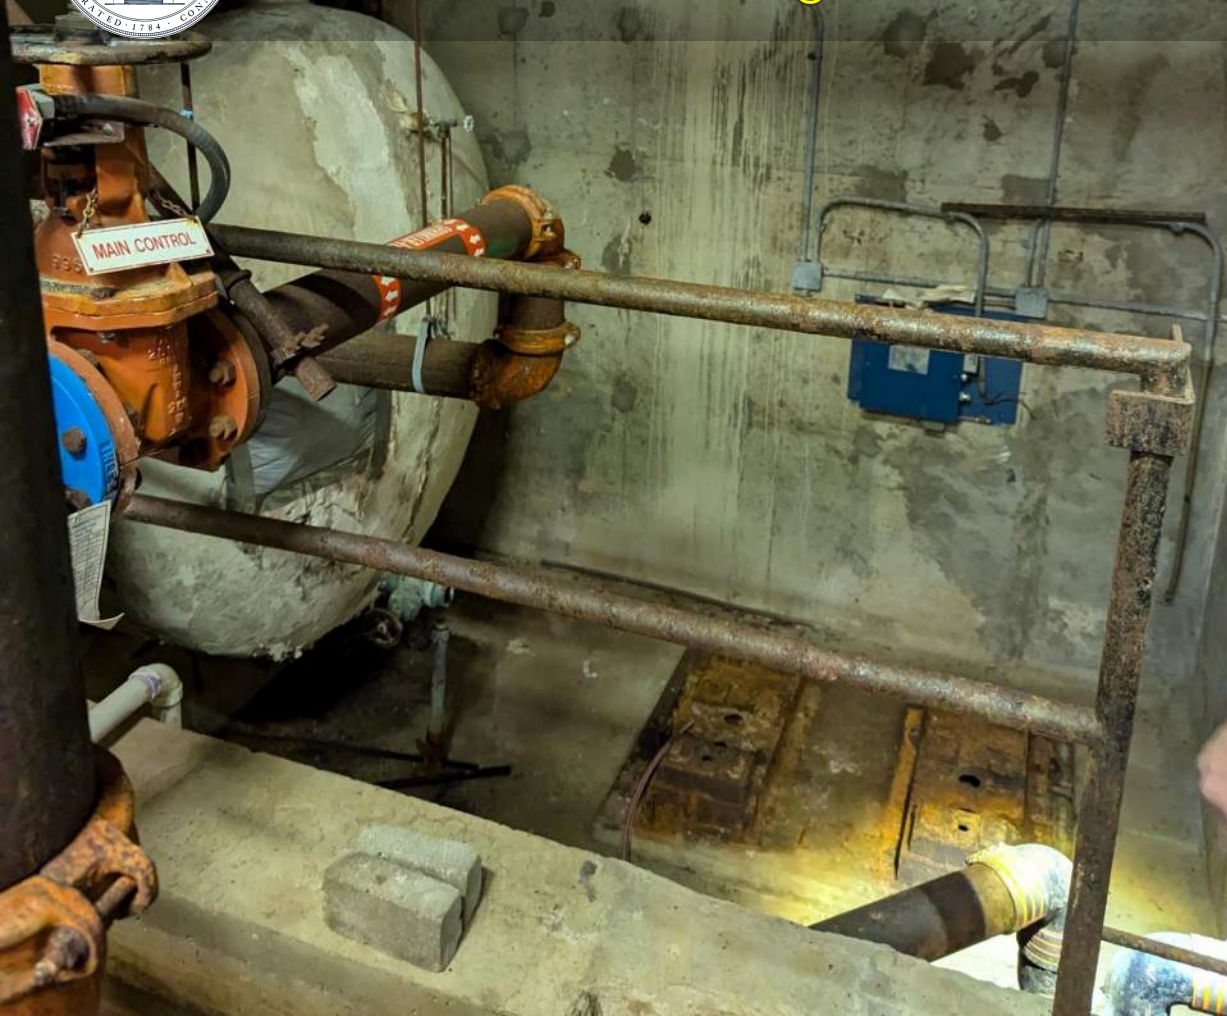
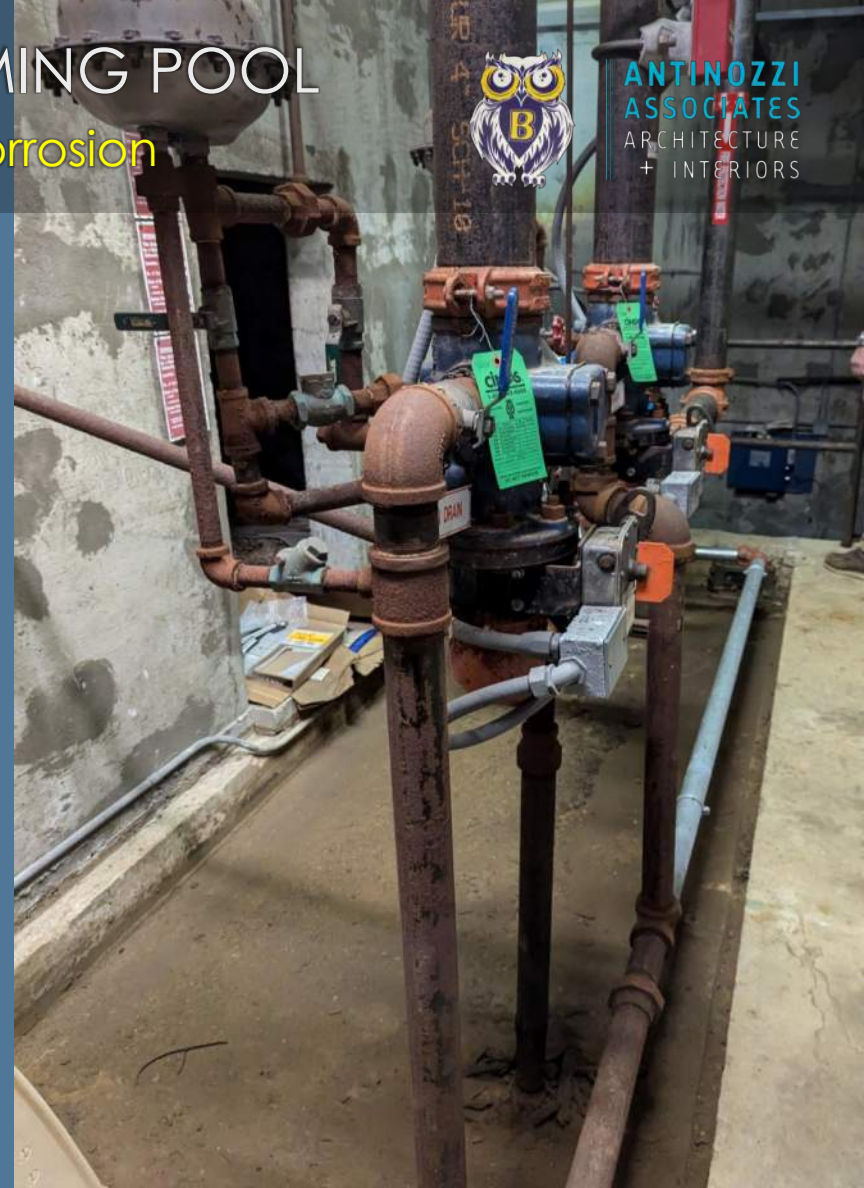
Pool and South wing Mechanicals - Corrosion

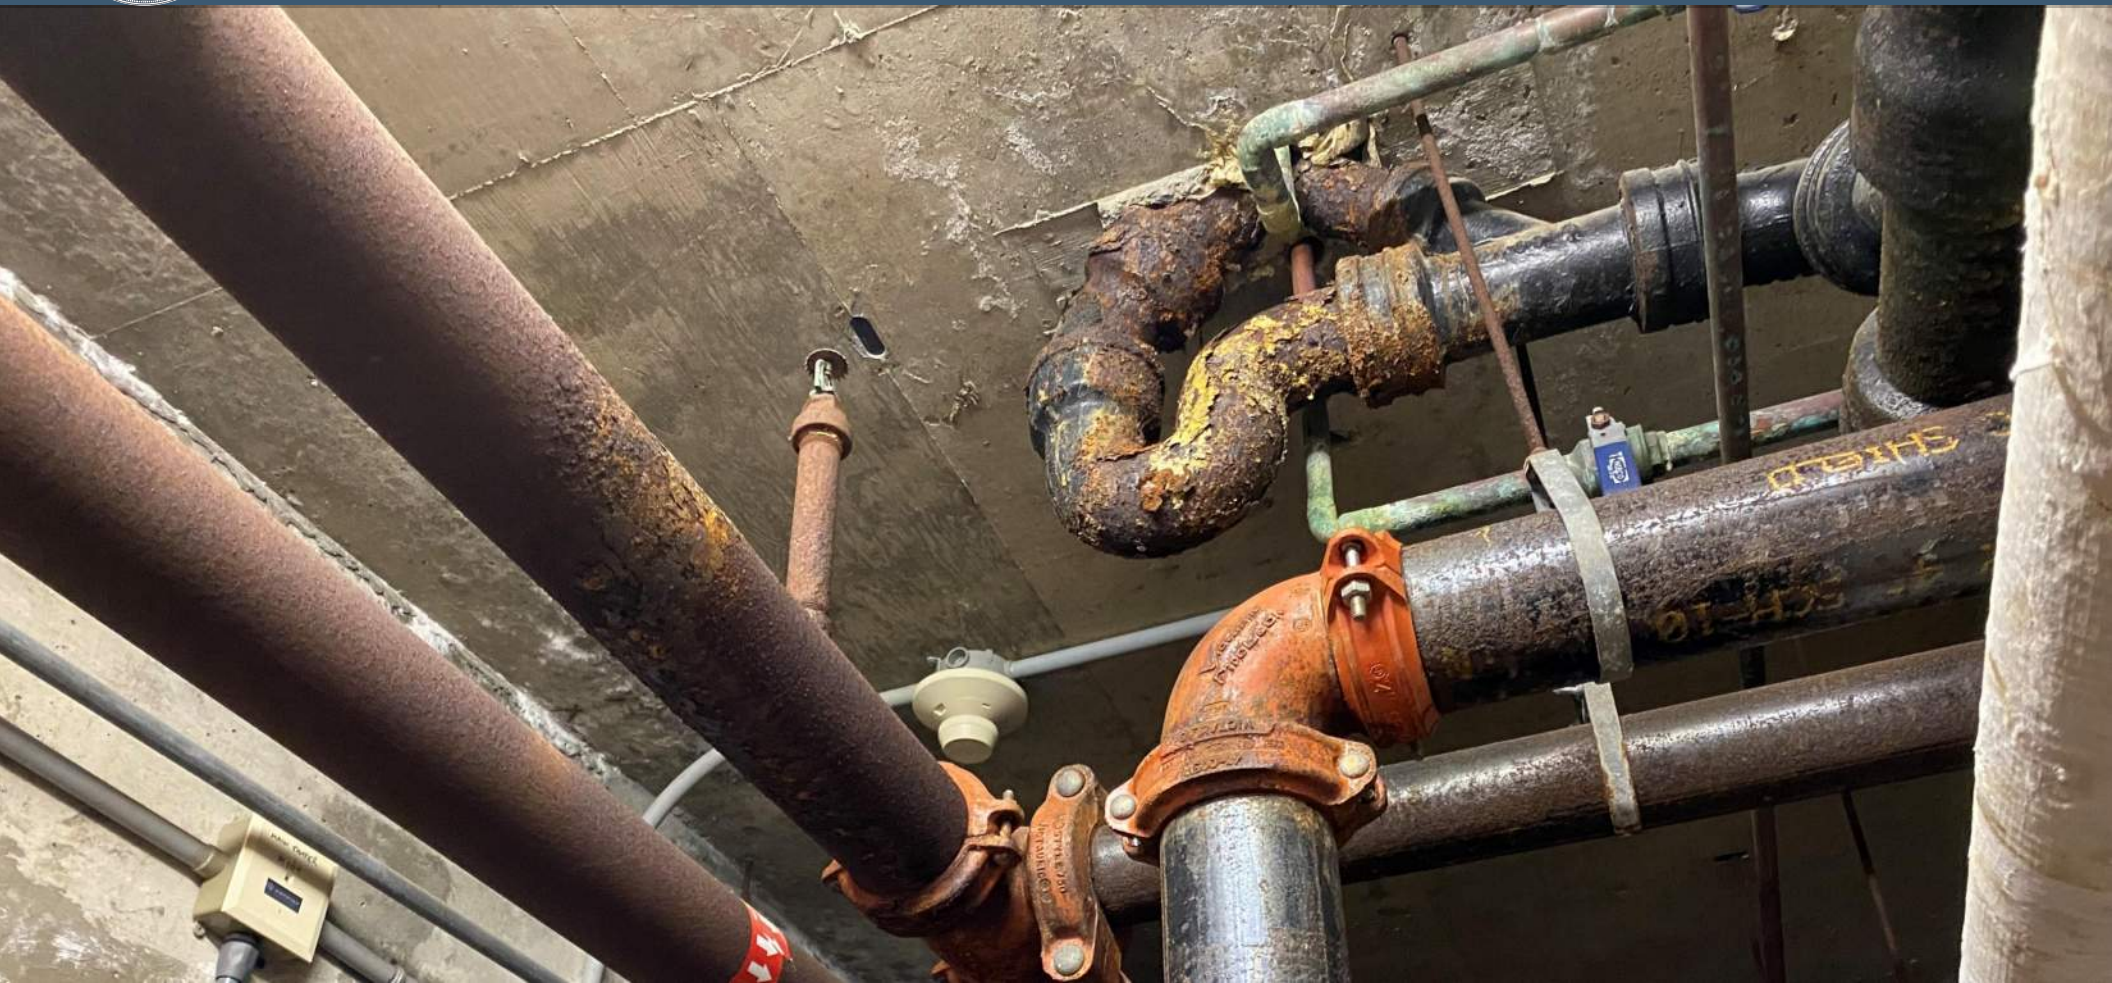
Pool and South wing Mechanical - Corrosion

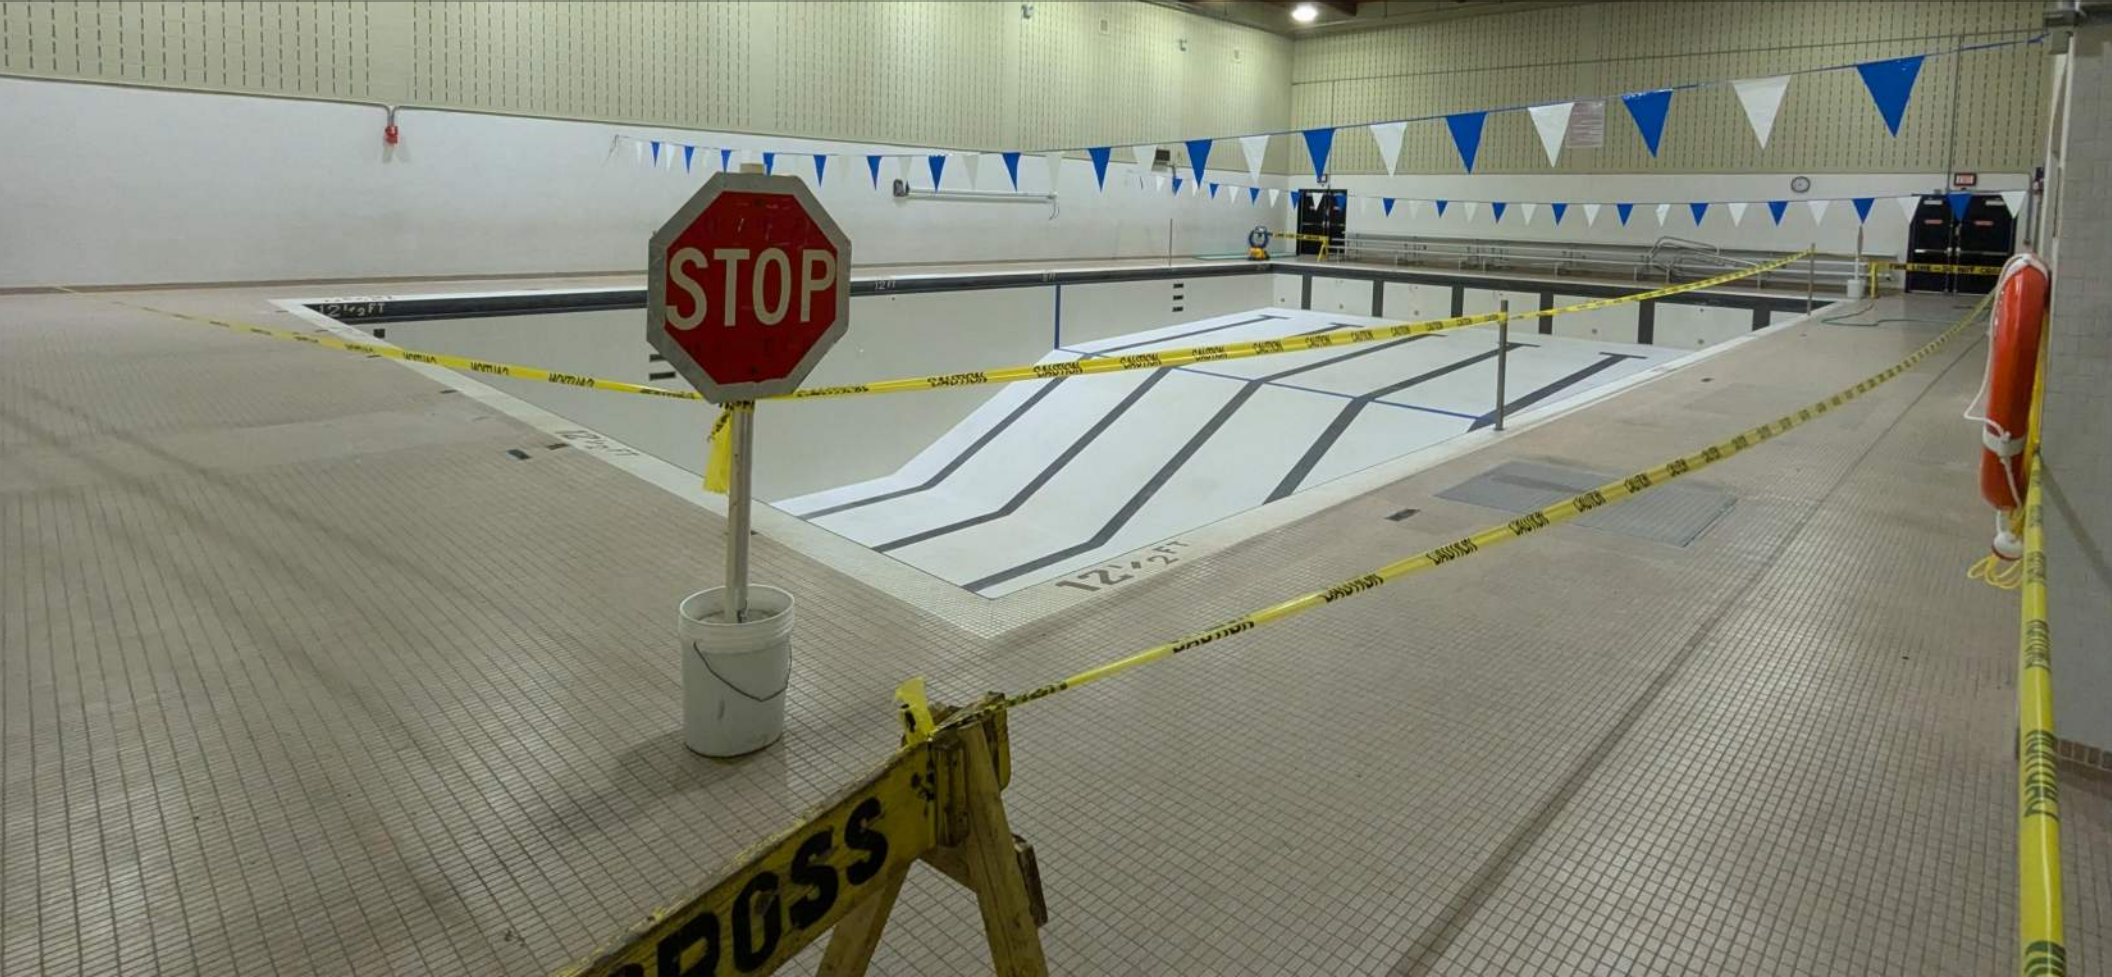
Closed pending repair and future use decisions

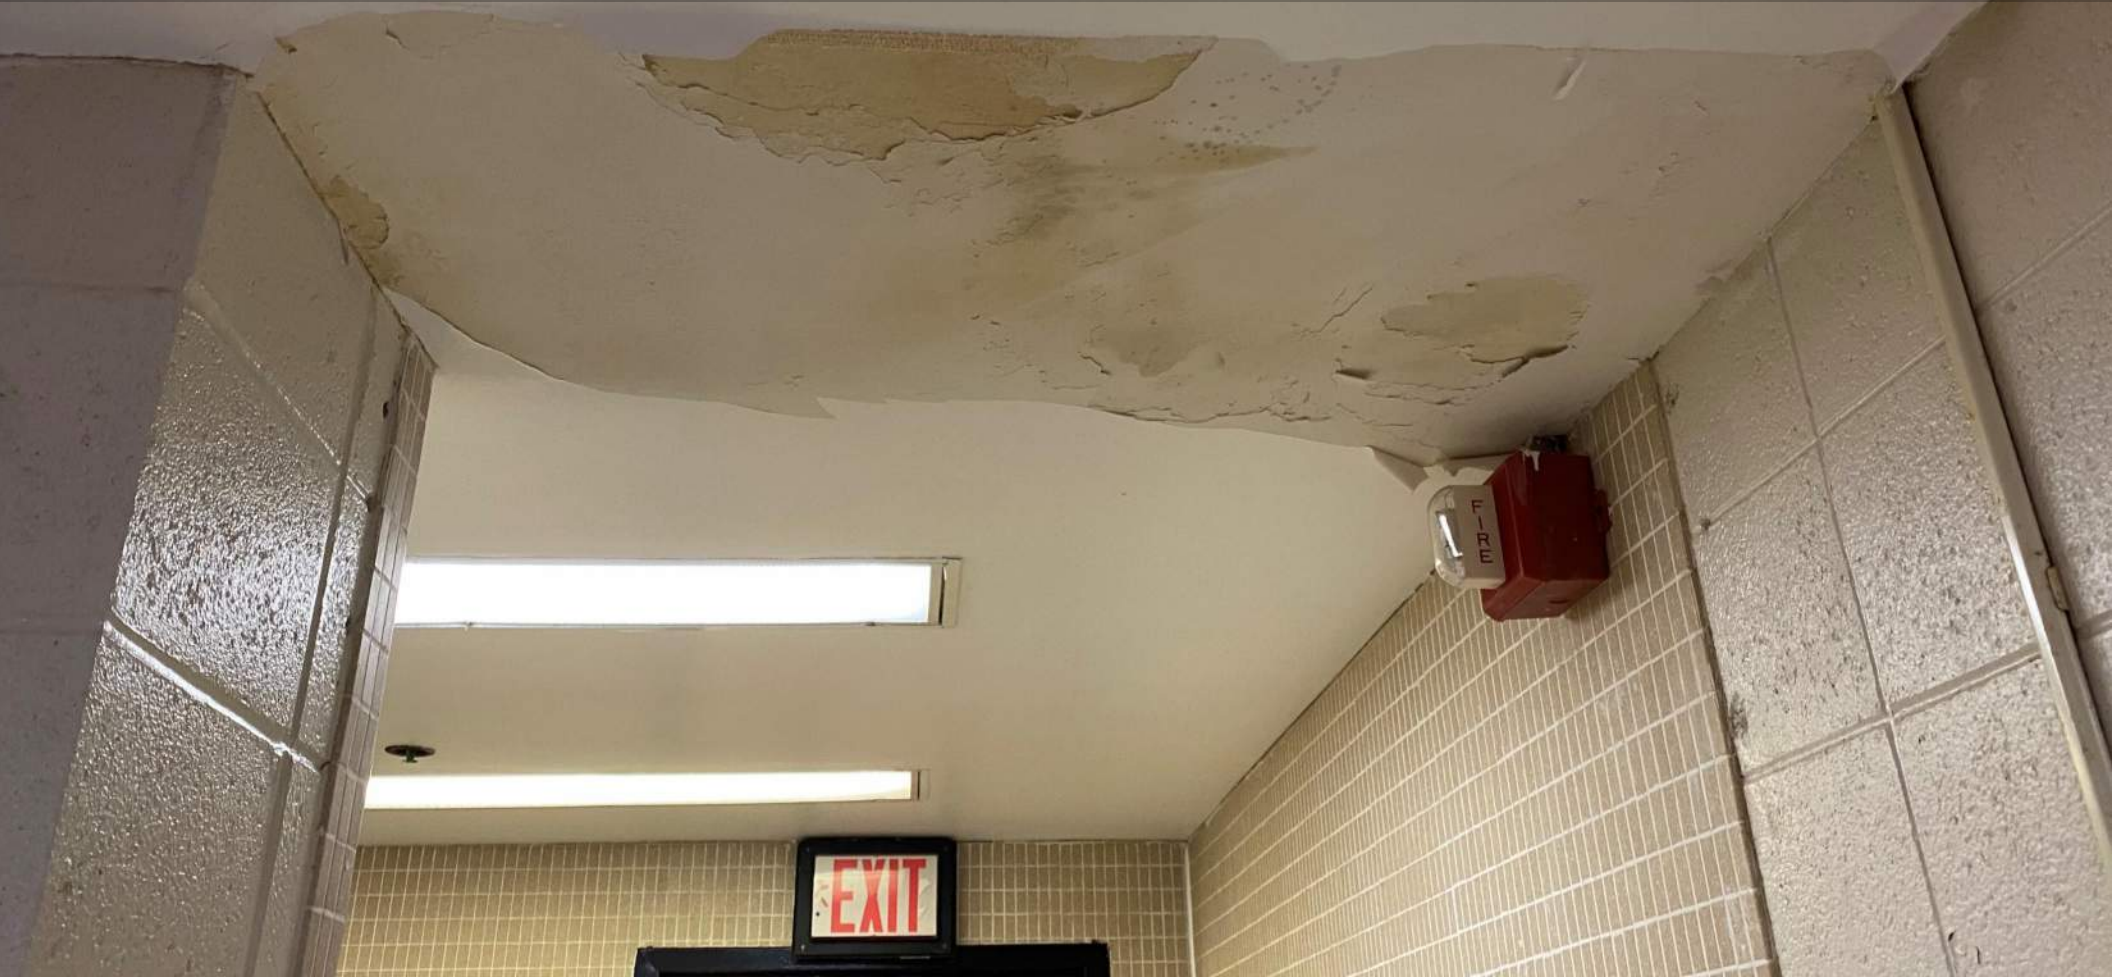
Community Locker Facilities – Water Damage

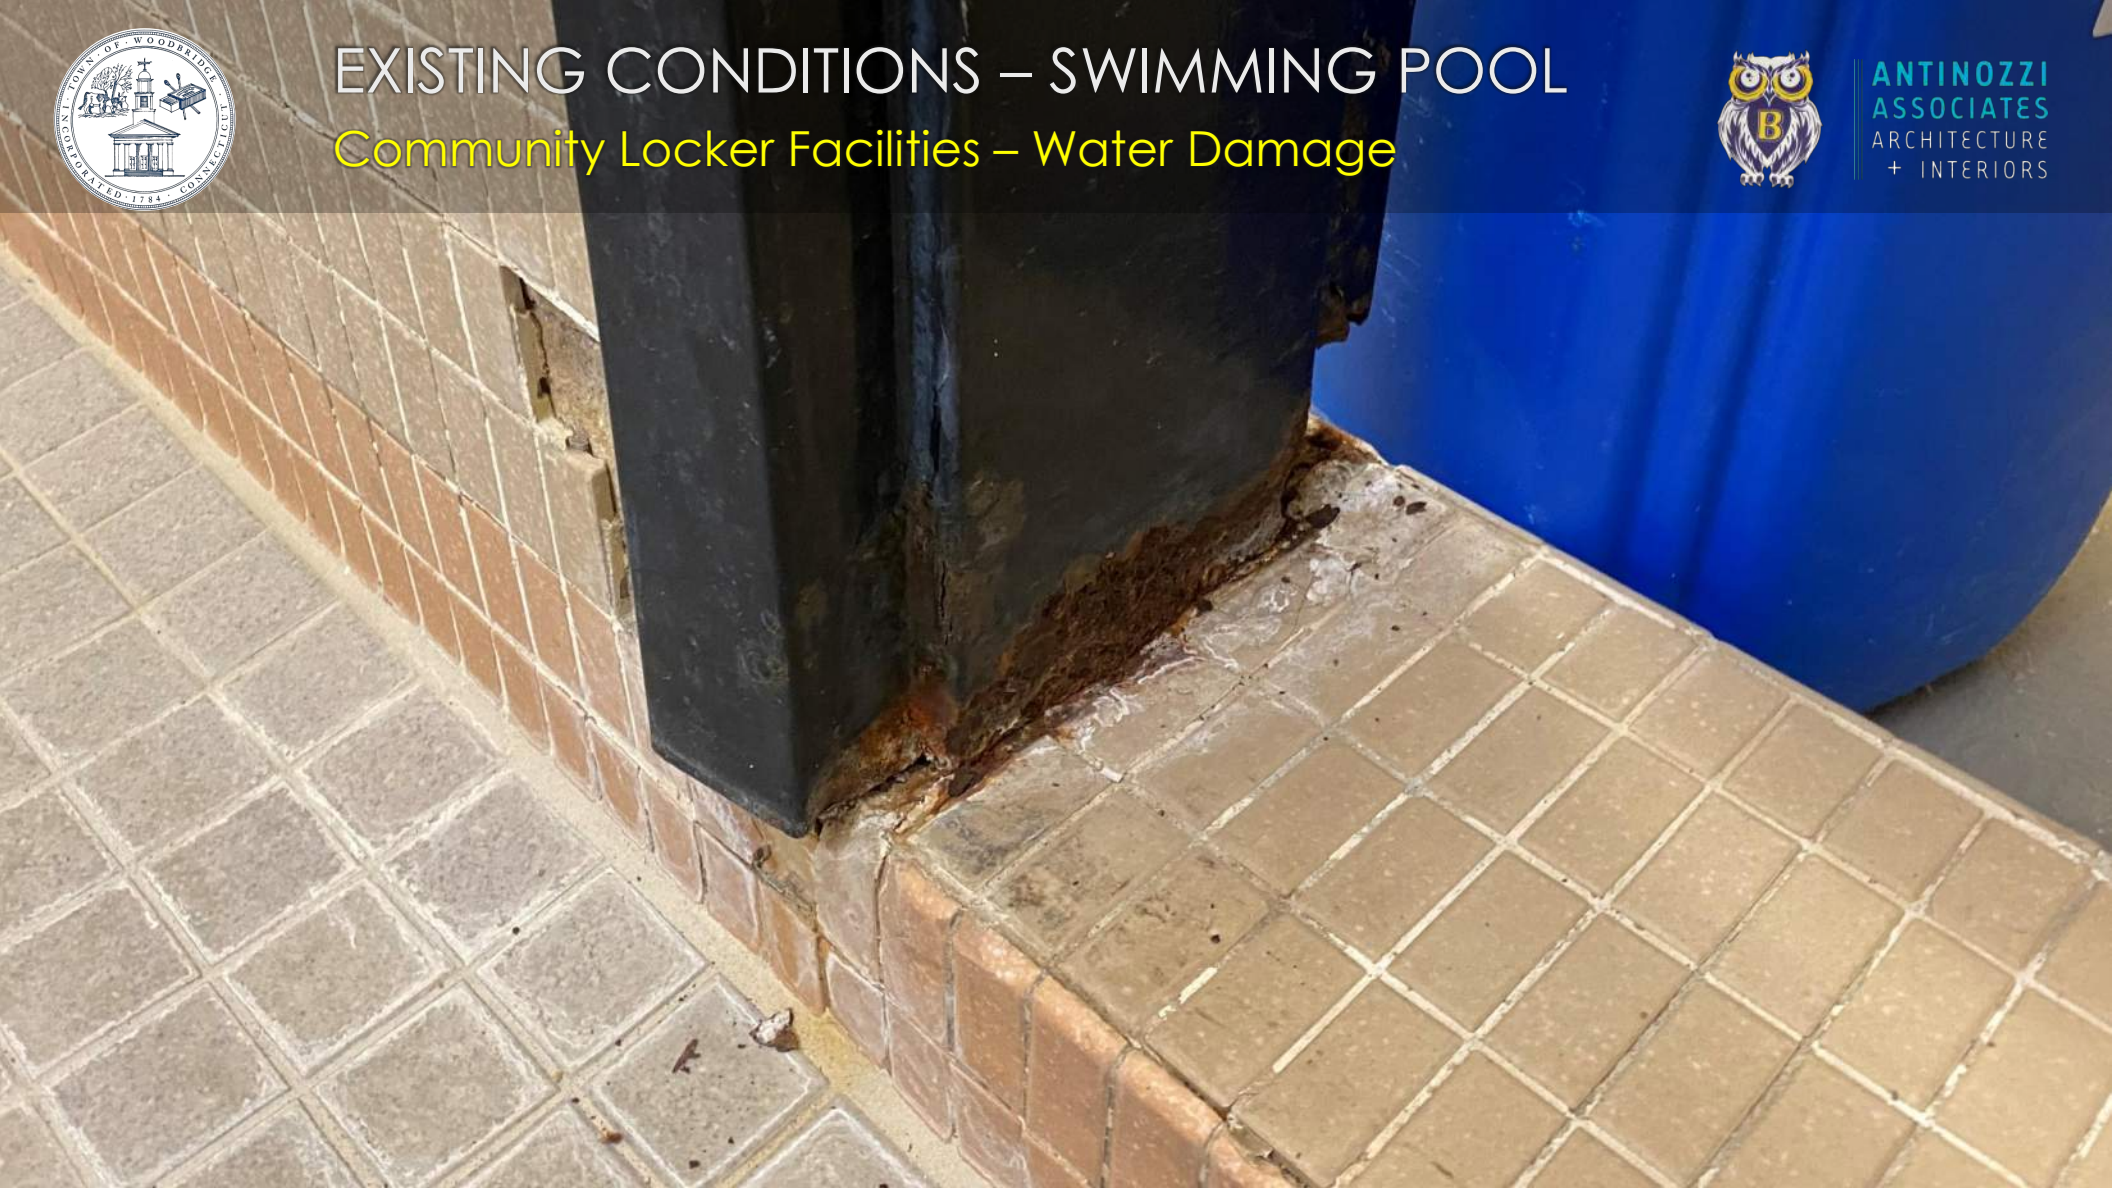
Community Locker Facilities – Water Damage
